Mata River Bed Level Trends, 1958 to 2016.

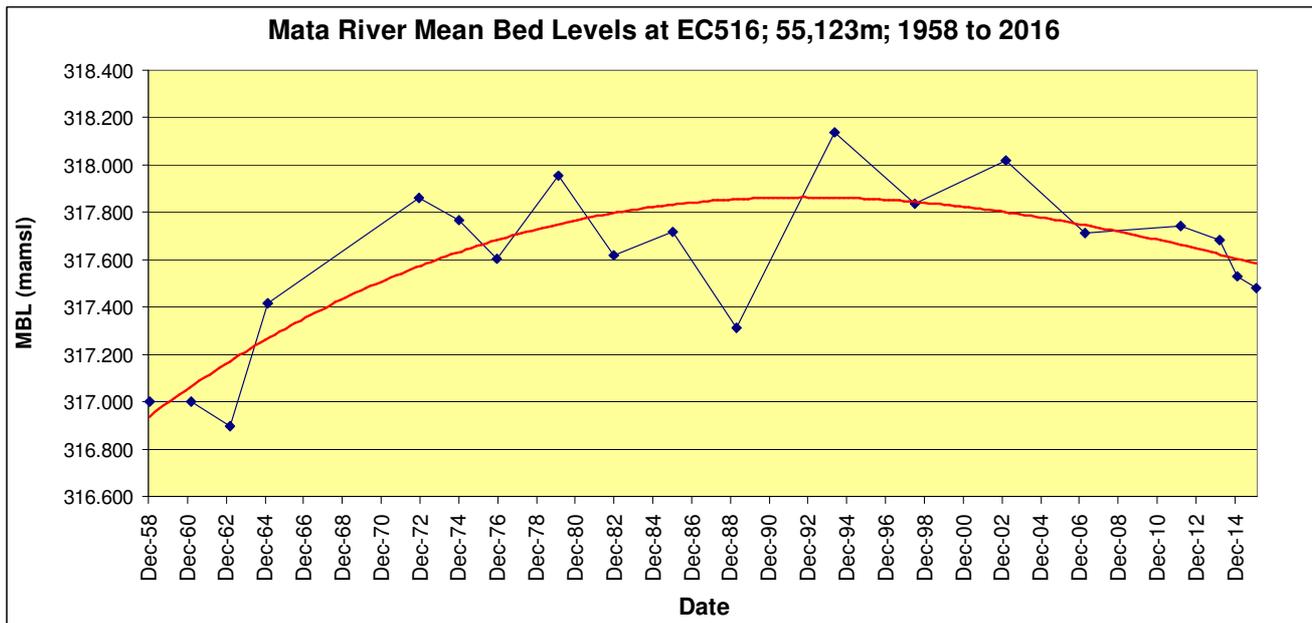
EC516; Mata Road Bridge.

This cross section is 55,123m upstream of the confluence with the Tapaeuroa River. The mean bed level (MBL) plot attached shows an aggrading river bed over the 22 years from 1958 to January 1980, then degrading until March 1989. This degradation may have been due to bed scour from major floods (1980, 1982 and 1988) over this period, followed by an excess of bedload material reaching the channel in subsequent years. From 1994 to 2016 the channel has degraded by 0.66m. Over this 22 year period the average rate of degradation is 30 mm/yr.

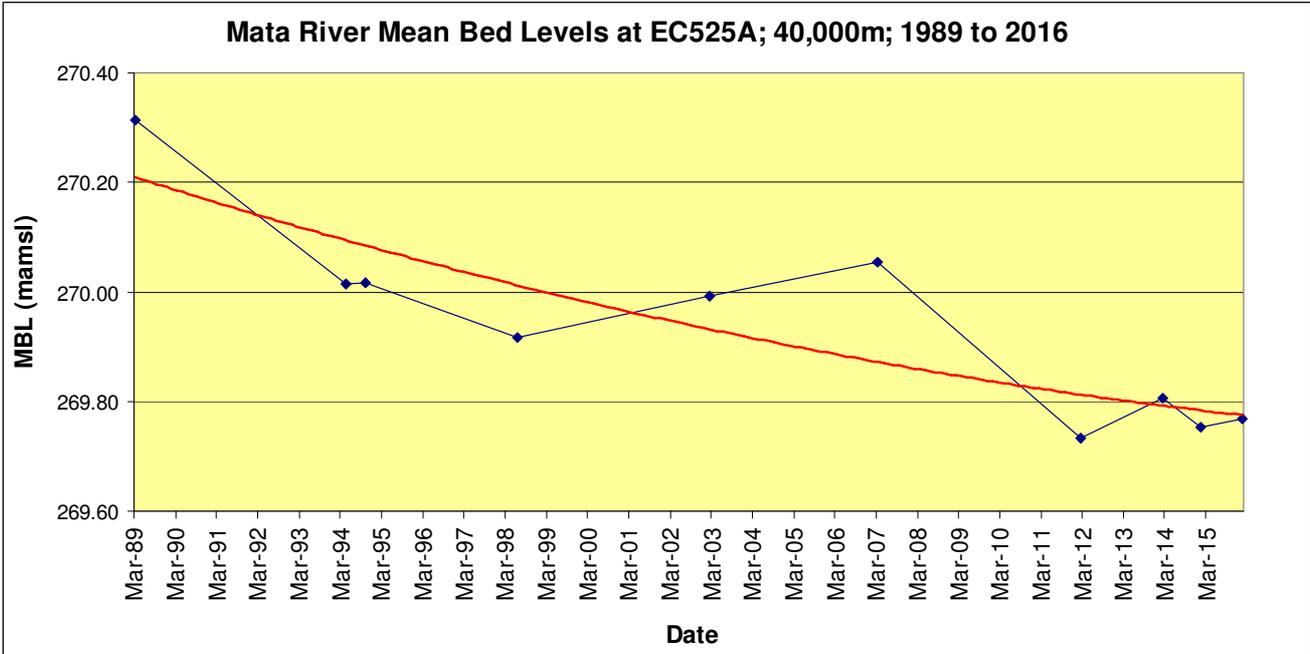
EC525A; Pouturu Bridge

The next downstream cross section is adjacent to the Pouturu bridge, approximately 40,000m from the confluence with the Mata river. Unfortunately the record is not as long as at EC516, the first survey being in 1989. However the MBL plot shows a drop of 0.3m between 1989 and 1994, fairly neutral between 1994 and 2007, and then a further drop of 0.29m by 2016; an average degrade of 30mm/yr over the past 9 years.

As for EC516, there has been no recorded shingle extraction upstream of this site for at least the last eight years.

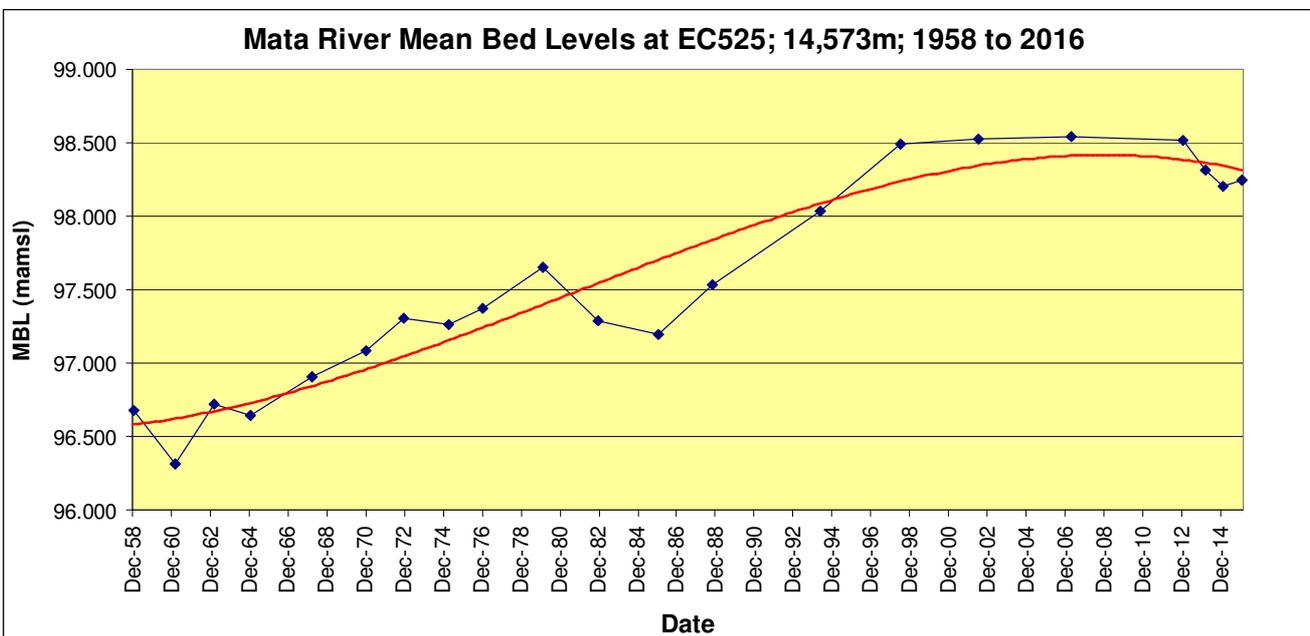
EC525; Makarika Road Bridge

This cross section is 14,573m from the confluence of the Mata and Tapaeuroa rivers, and is the most downstream of all the cross sections on the Mata River. It is sited just upstream of the Makarika Road bridge. Unfortunately there is also a major shingle extraction site (RS 206002; Fulton Hogan), on the shingle beach through this cross section.

The above plot shows river bed aggradation of 0.98m at this cross section over the 22 year period between 1958 and 1980, at an average rate of 45 mm/yr. This is followed by a short period of bed degradation between 1980 and 1985, which may have been a result of scouring processes from major floods in the river in 1980 and 1982. (Note that while scour may occur during major floods, more bedload material is also released from headwater gullies which inevitably will be transported downstream and cause aggradation months or years later).

After 1985 the aggradation at this site continues until 1998, after which there is a 14 year neutral period (1998 to 2012), and channel degradation since then.

Because of the shingle extraction on the same gravel beach as the Makarika Road bridge cross section, the MBL results at this site cannot be considered to be a reliable indicator of bed level trends. An average of 18,500 cubic metres of shingle per year has been extracted from the Makarika bridge site over the past 8 years which is bound to have reduced the transport of shingle downstream, as the depositional beach has to be recharged with shingle again from upstream. Further upstream in the Waitahaia River, an average of some 20,000 m³ per year of shingle has been extracted over the past 8 years. This is expected to have a delayed effect at Makarika Bridge which may take many years (or one major flood) to transport bedload at “normal” (i.e., pre-shingle extraction operation) rates from the Waitahaia River into the Mata.
