WAIORONGOMAI RIVER BED LEVEL TRENDS; 1979 to 2014

Introduction:

This is the second in a series of reports on river bed level trends in the Waiapu catchment, Ruatoria, commissioned by the Environmental section of the Gisborne District Council.

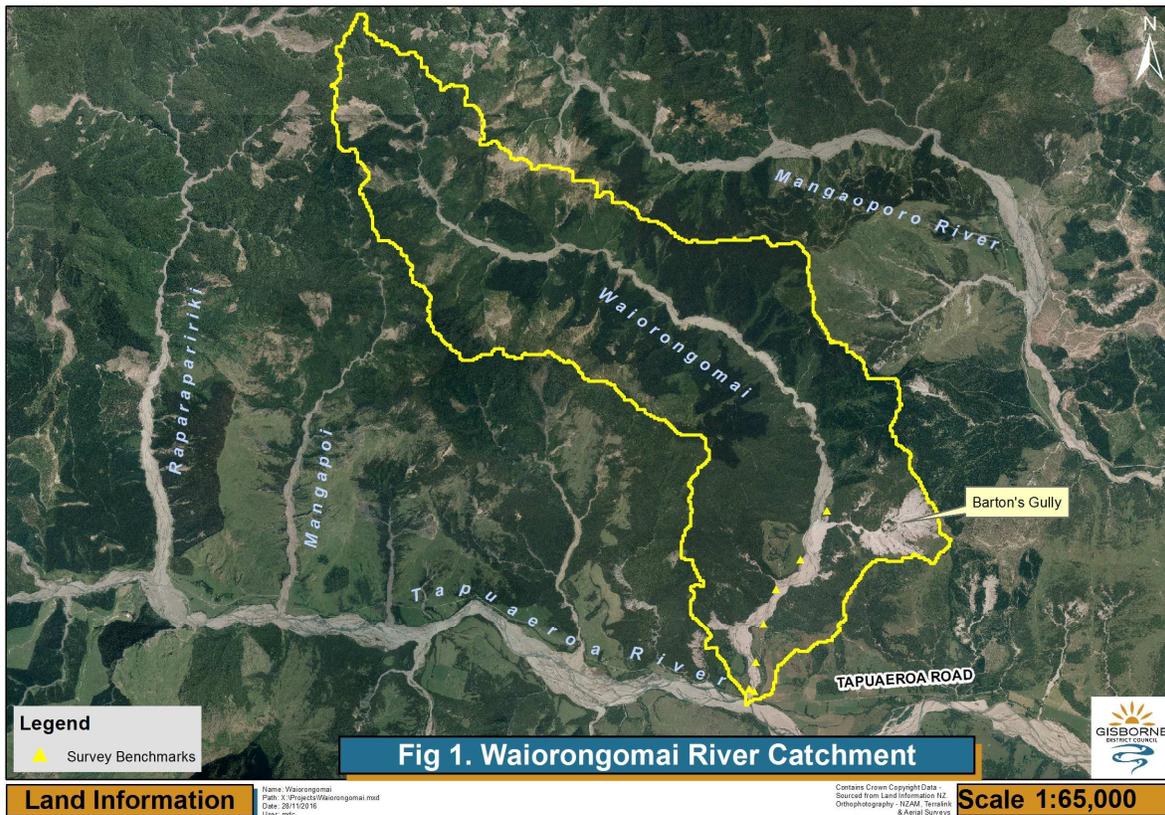
The Waiorongomai River is a major tributary of the Tapuaeroa River, and has a catchment area of 36.84 square kilometres. It has its headwaters in the Raukumara ranges on the opposite side of the ridge where the Raparapaririki river has its headwaters. While the Raparapaririki flows generally from north to south, the Waiorongomai flows more in an east-south-easterly direction, turning south about five to six kilometres upstream of the confluence with the Tapuaeroa River; see Fig. 1. The main channel length is approximately 14km.

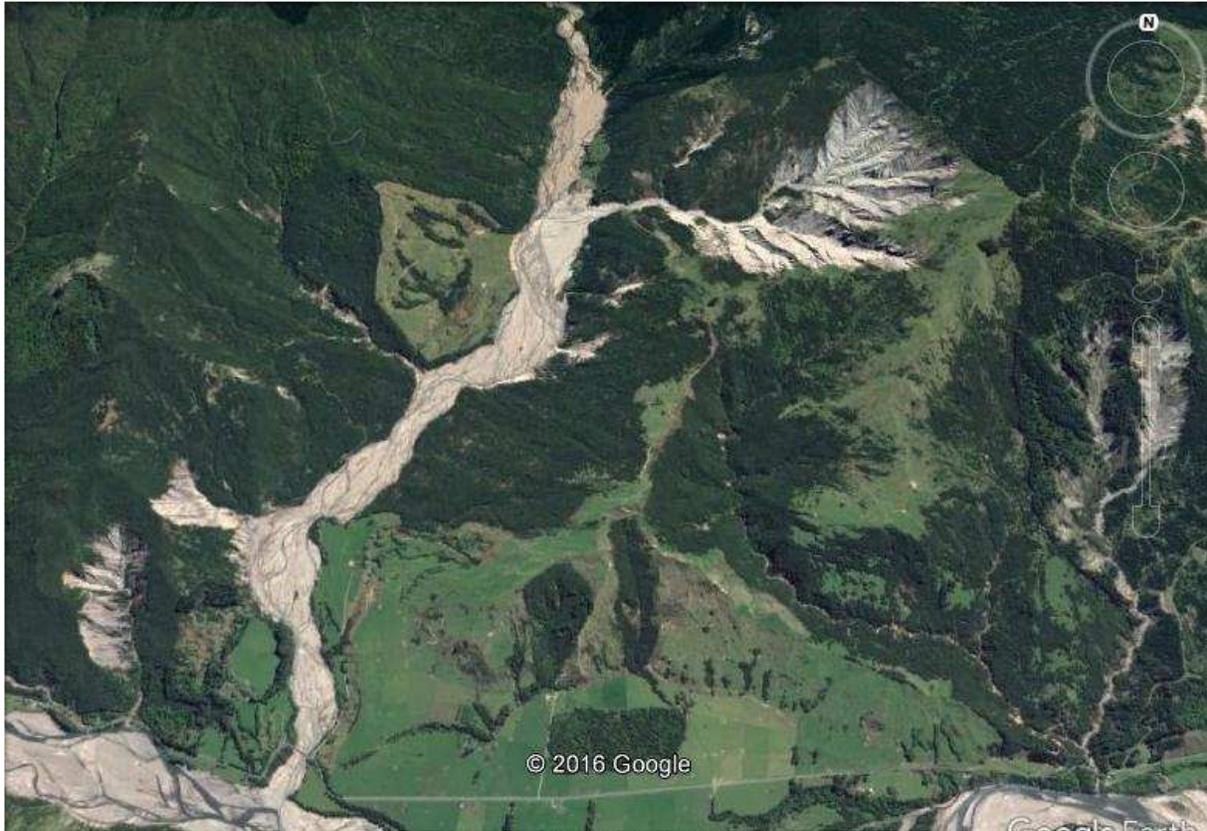
Fig. 9: Barton's gully (top right); the Waiorongomai river centre, and Tapuaeroa River at bottom left. (Google Earth photo; dated October 2014).

Note the lighter grey colour of the bed load material originating from Barton's gully compared to the material in the Waiorongomai river channel upstream of Barton's gully.

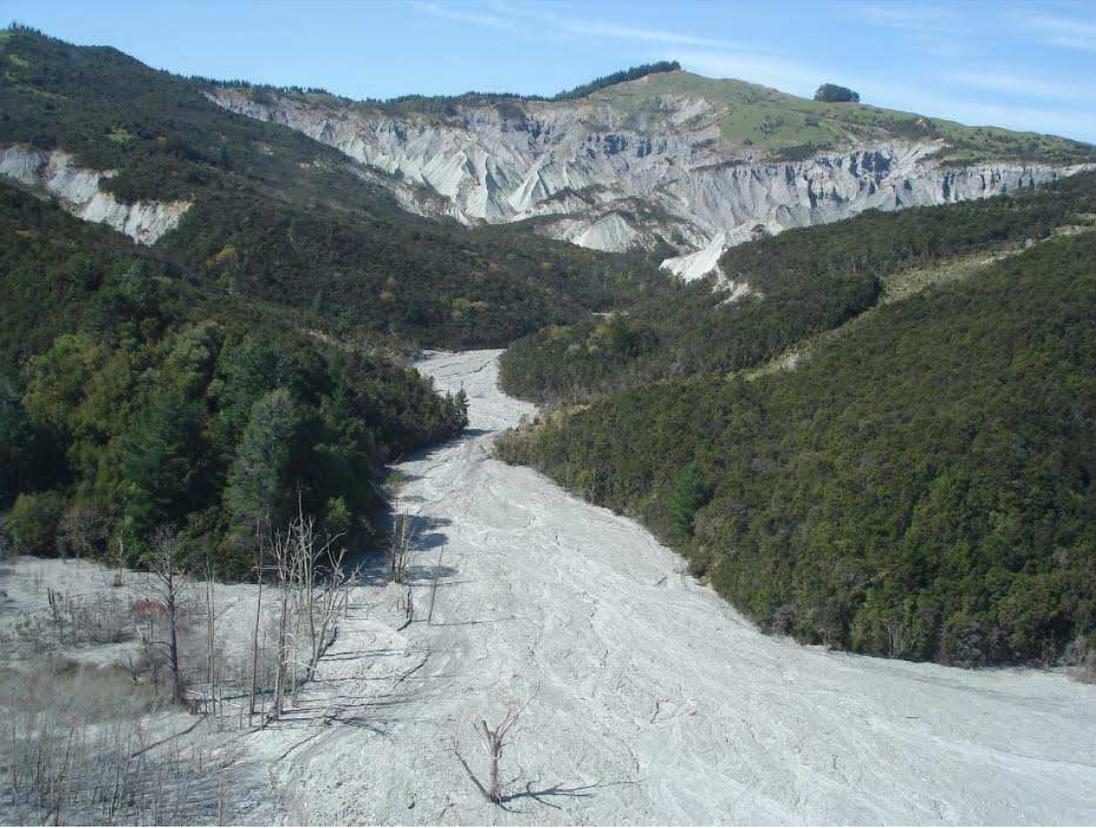
Fig. 10: Gravel and silt spewing out from Barton's gully into the Waiorongomai River (foreground). The red roofed whare shown in Fig.11 can be seen behind the dead trees, left foreground. Photo: Courtesy of Dr. M Marden; photo date: 2009.

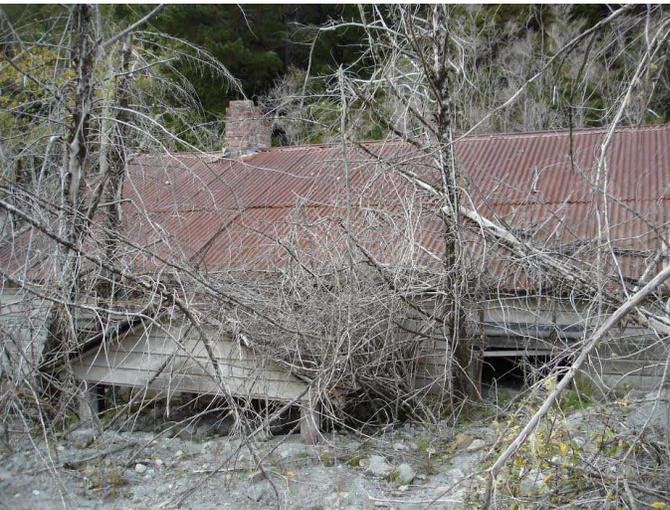
Fig. 11: The whare, partially buried by gravel and silt from Barton's gully. Photo: Courtesy of Dr. M Marden; photo date: 2009.
