BEFORE AN INDEPENDENT COMMISSIONER APPOINTED BY THE GISBORNE DISTRICT COUNCIL

The Resource Consent application for coastal erosion management works at Wainui Beach lodged by Gisborne District Council

STATEMENT OF EVIDENCE OF THOMAS DUNCAN SHAND

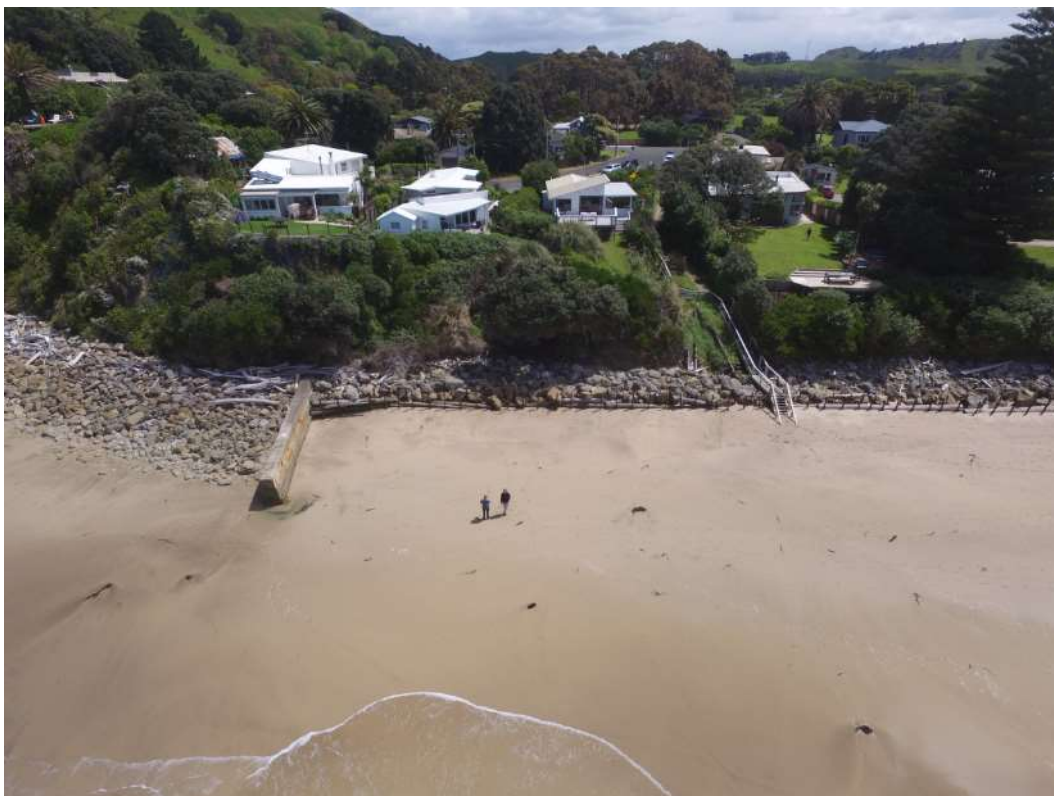
Figure 1 Location of proposed rock revetment between the existing concrete groyne and Tuahine Crescent accessway

- 3.3 A rock revetment is proposed to replace the existing rock and rail wall between the concrete groyne south of the Tuahine beach accessway and 2 Tuahine Crescent (Figure 1). The works involve the removal of the existing railway irons and log wall, stockpiling of the existing rock, construction of a new rock revetment and removal of all debris and construction material from the CMA.

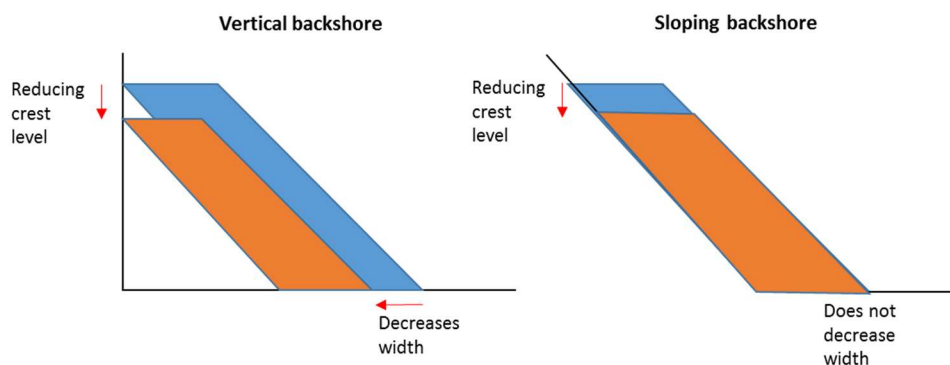
Figure 4 Change in total and apparent width for the proposed sloping structure compared to existing

- 8.6 The current design crest level of RL 4.85 m is suitable for the present day but may need to be increased in the future. This is not expected to increase the structure width. Likewise, decreasing the width to allow for higher levels of overtopping or for a more frequent event is not likely to reduce the footprint until the structure reaches the vertical part of the slope, immediately above the existing structure. However, a crest at this level is too low to provide any appreciable benefit of reducing overtopping-induced erosion compared to the existing structure and is not recommended.
