**EXTRAORDINARY COUNCIL/TE KAUNIHERA**  
DATE: Wednesday 6 November 2024  
TIME: 9:00AM  
AT: Te Ruma Kaunihera (Council Meeting Room), Awarua, Fitzherbert Street, Gisborne

24-314

**Grey Street, Gisborne – Streets For People**  
**Post-Construction Stage Safe System Audit Report**  
**Prepared for Gisborne District Council**

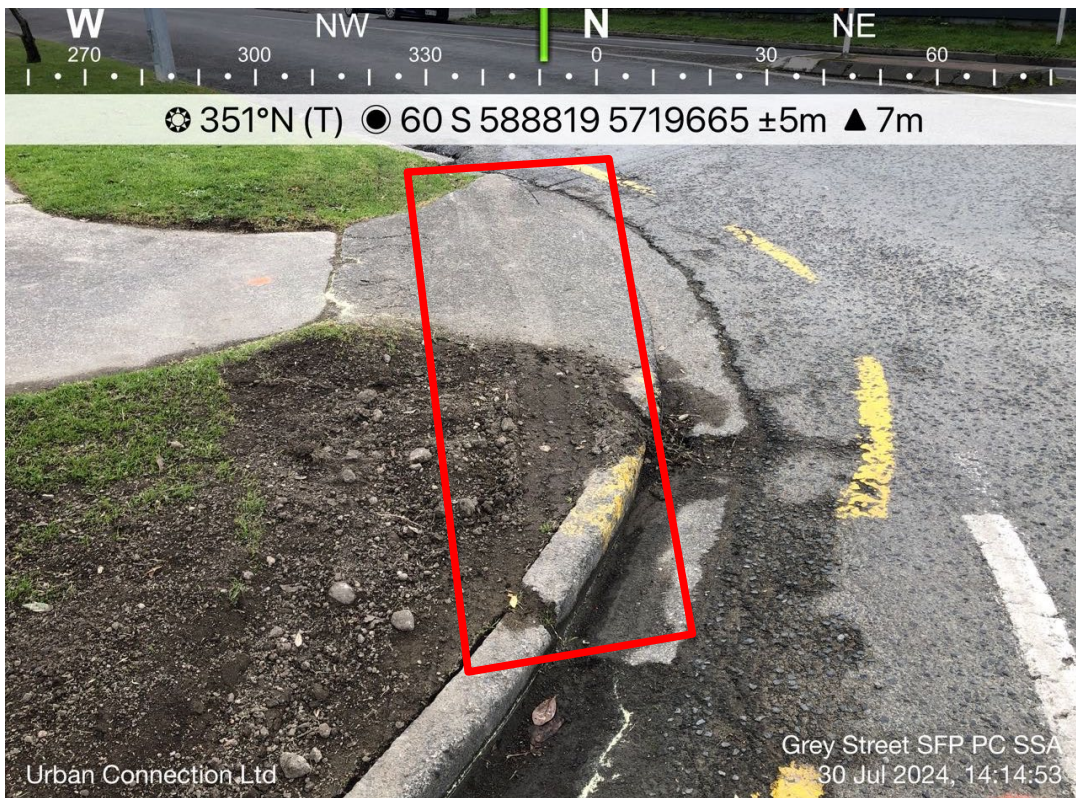
<ul style="list-style-type: none"> <li>Heavy vehicle versus pedestrian</li> </ul>
<b>Probability</b>	Very Unlikely	<ul style="list-style-type: none"> <li>Low turning speeds</li> <li>Low frequency of longer HCVs</li> </ul>
<b>Severity</b>	Serious	<ul style="list-style-type: none"> <li>Impact speeds generally expected to be below 30 km/h; however, serious outcome could be generated in the event of a heavy vehicle v. pedestrian</li> </ul>

Figure 4.4-7 – Wheel tracks on the berm and footpath

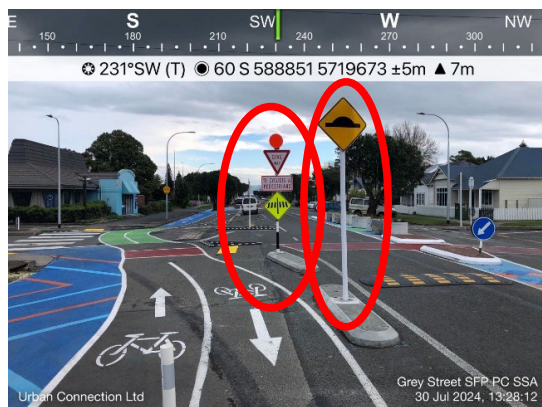
**Figure 4.4-8 – Signage at the northeastern approach of the Grey Street/Kahutia Street intersection**

- Grey Street/Kahutia Street intersection:
  - Northeastern approach: four signs are provided on a single pole, including an orange disk sign, a give-way sign, a supplementary 'to cyclists & pedestrians' sign and a pedestrian crossing sign. Note that the orange disc A hump sign is provided approximately 10 m before (refer to Figure 4.4-8);
  - Southeastern approach: three signs are provided on a single pole, including a give-way sign, a supplementary 'to cyclists & pedestrians' sign and a pedestrian crossing sign (refer to Figure 4.4-9). No orange disc and black & white pole is provided at the pedestrian crossing;
  - Southeastern and northwestern approaches: two signs are provided on a single pole adjacent to the limit line, including a stop sign and a no-right-turn sign (refer to Figure 4.4-9);

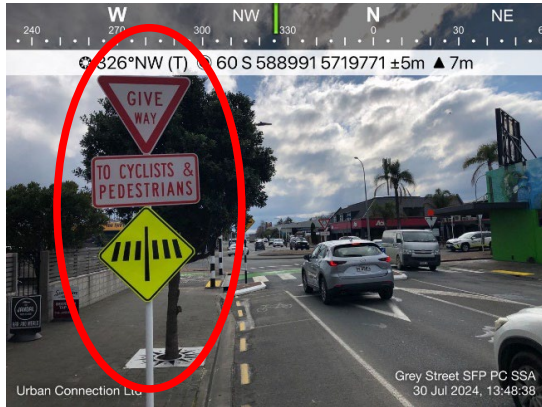
**Figure 4.4-10 – Signage at the southeastern approach of the Grey Street/Childers Road intersection (westbound direction)**

- Grey Street/Childers Road intersection:
  - Southeastern approach (westbound direction): three signs are provided on a single pole, including a give-way sign, a supplementary 'to cyclists & pedestrians' sign and a pedestrian crossing sign (refer to Figure 4.4-10);
  - Southeastern approach (westbound direction): two signs are provided on a single black & white pole, including an orange disk and a hump sign (refer to Figure 4.4-11);

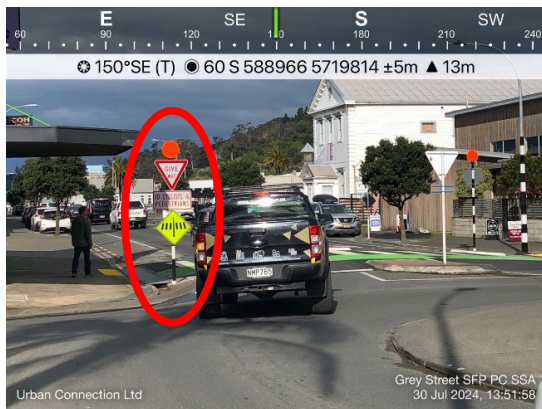
**Figure 4.4-12 – Signage at the southeastern approach of the Grey Street/Childers Road intersection (eastbound direction)**

- Southeastern approach (eastbound direction): four signs are provided on a single black & white pole, including an orange disk sign, a give-way sign, a supplementary 'to cyclists & pedestrians' sign and a pedestrian crossing sign (refer to Figure 4.4-12);

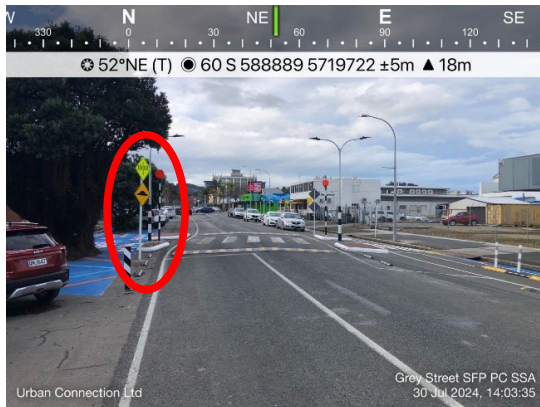
**Figure 4.4-13 – Signage at the zebra crossing on Grey Street (northbound direction)**

- Zebra Crossing on Grey Street:
  - Both approaches: two signs are provided on a single pole, including a pedestrian crossing sign and a hump sign (refer to Figure 4.4-13 and Figure 4.4-14);

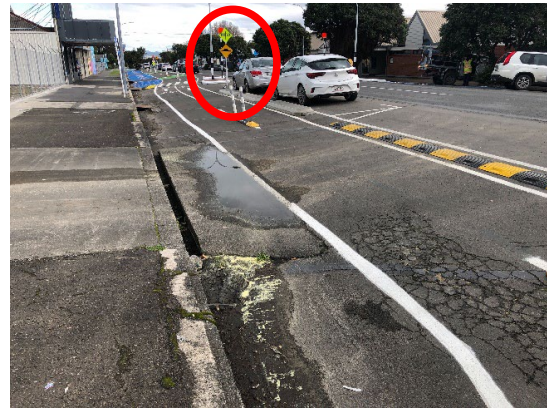
**Figure 4.4-14 – Signage at the zebra crossing on Grey Street (southbound direction)**

- Replace the Give way + supplementary with a RP63 +RP65, sharing a new pole further to the North east.

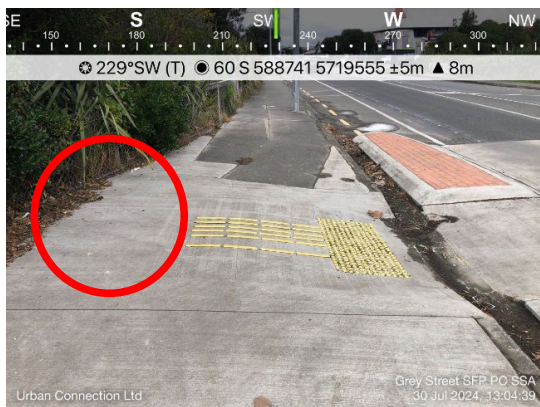
- No directional (leading) tactile indicators are present to lead the vision impaired to the crossing points. These users have no guidance as to where to cross the road;
- Missing or poorly installed warning (hazard) tactile indicators at several locations throughout the section, including:
  - Warning tactiles too close to the traffic lanes or cycleway;
  - No warning tactiles on the pedestrian refuge at the northeastern side of the Grey Street/Kahutia Street intersection;
  - No warning tactiles through Kahutia Street (W) and courtesy crossing adjacent to the Childers Road intersection;

**Figure 4.4-15 – Directional tactiles do not cover the entire footpath**

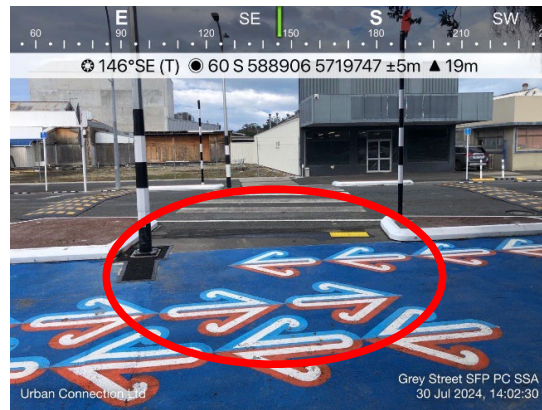
**Figure 4.4-22 – No warning and directional tactiles at the pedestrian crossing on Grey Street**

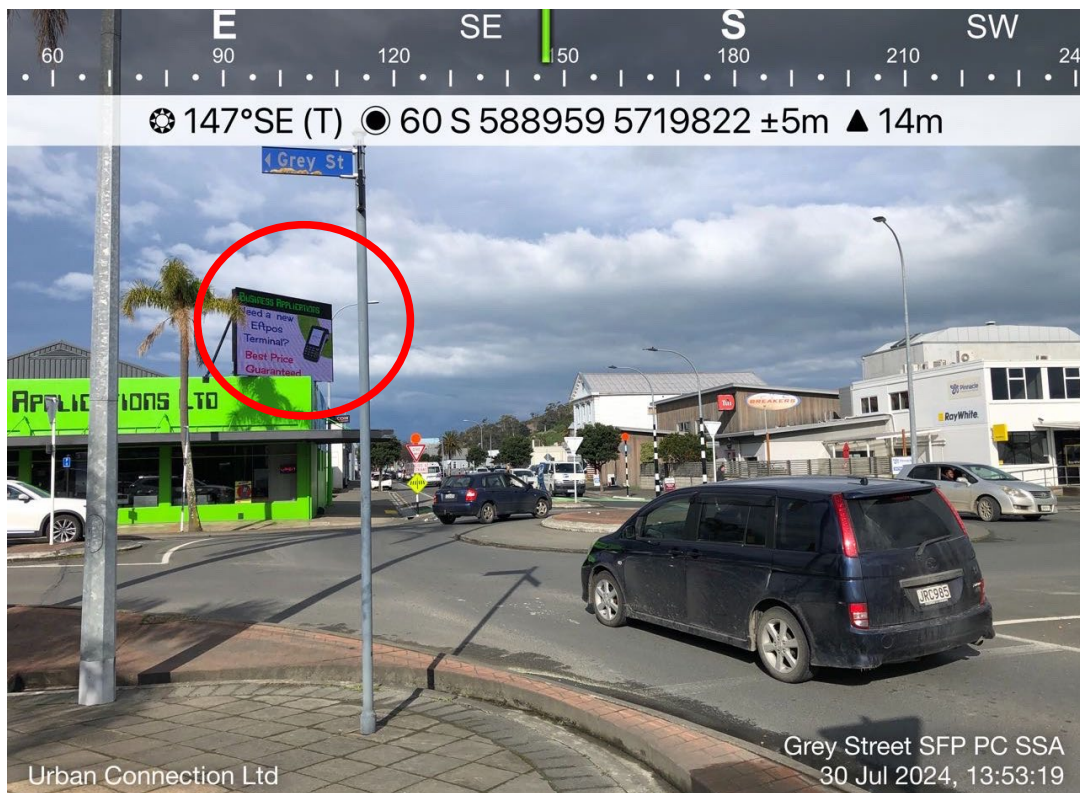
<ul style="list-style-type: none"> <li>Vehicle against pedestrians</li> </ul>
Probability	Unlikely	<ul style="list-style-type: none"> <li>Low speeds due to roundabout;</li> </ul>
Severity	Serious	<ul style="list-style-type: none"> <li>Impact speeds generally expected to be below 30 km/h; however, serious outcome could be generated if a child/elderly is involved.</li> </ul>

Figure 4.4-23 – Electronic Billboard/Sign

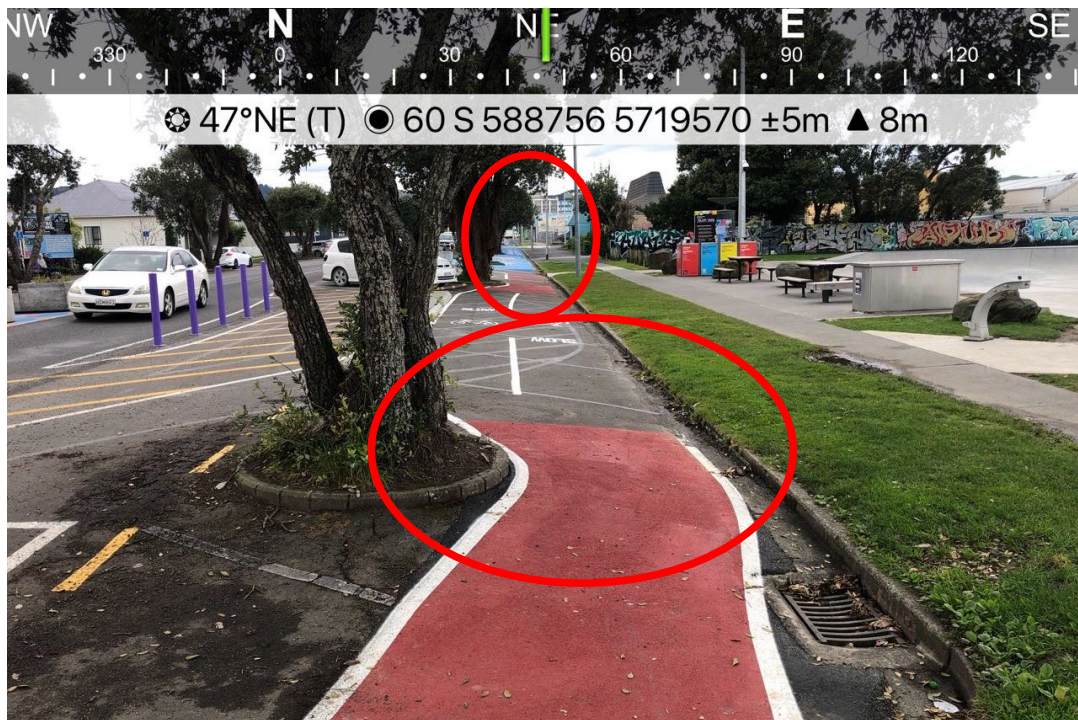
**Figure 4.4-24 – Pinch points in front of the skate park**

<ul style="list-style-type: none"> <li>Between vulnerable road users (cyclist v cyclist)</li> </ul>
<b>Probability</b>	Very Unlikely	<ul style="list-style-type: none"> <li>Low cyclist speed;</li> <li>Low-moderate cycle volumes;</li> <li>Good forward visibility;</li> </ul>
<b>Severity</b>	Minor	<ul style="list-style-type: none"> <li>Low impact speeds of less than 30 km/h</li> </ul>

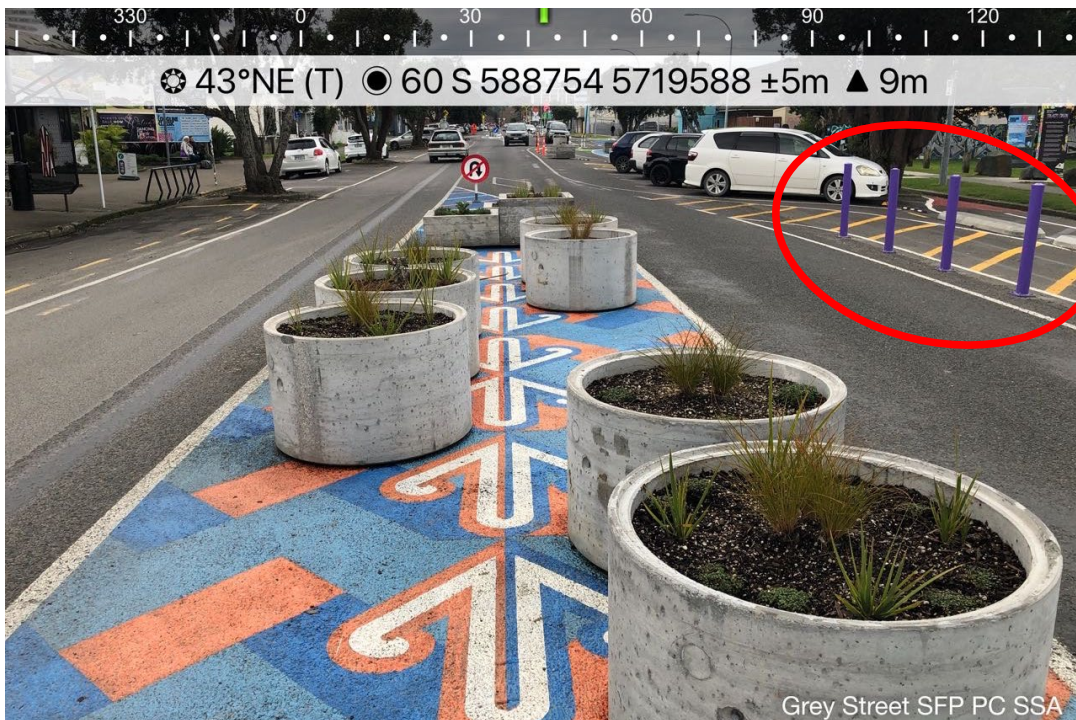
<ul style="list-style-type: none"> <li>Vehicle against non-frangible hazard</li> </ul>
<b>Probability</b>	Very Unlikely	<ul style="list-style-type: none"> <li>Low vehicle speeds;</li> <li>Good forward visibility;</li> </ul>
<b>Severity</b>	Minor	<ul style="list-style-type: none"> <li>Low impact speeds of less than 30 km/h</li> </ul>

**Figure 4.4-25 – Planter boxes and purple bollards adjacent to traffic lanes**

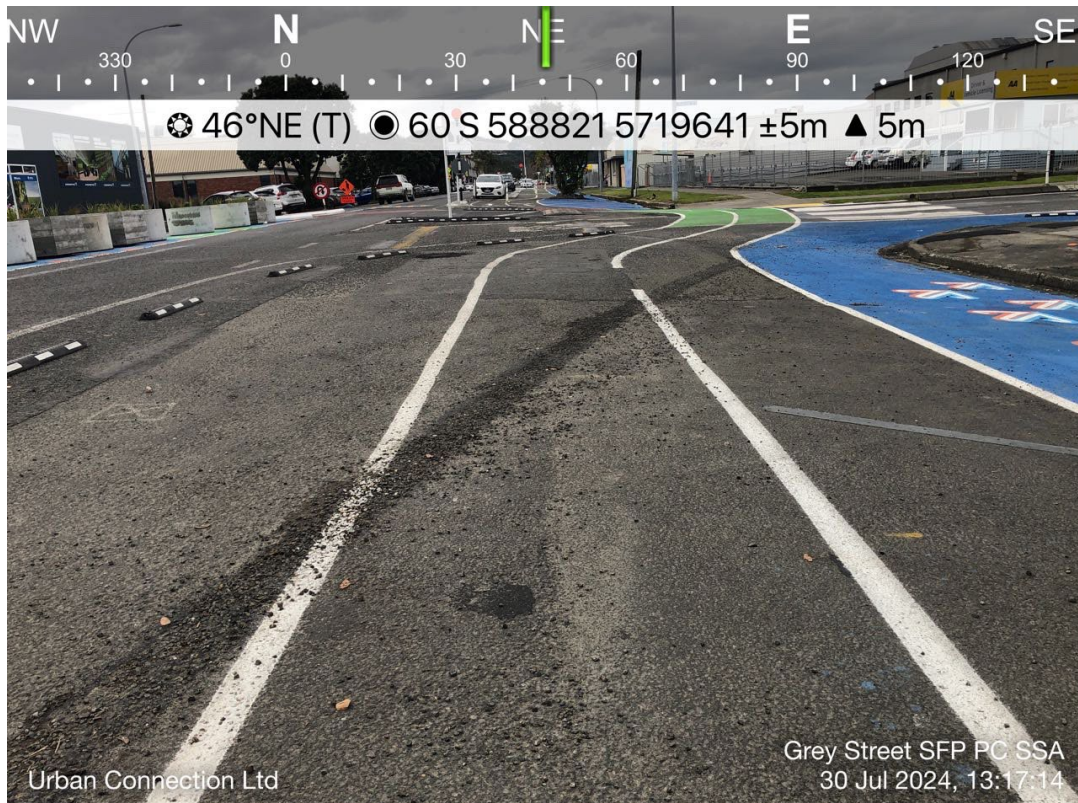
<ul style="list-style-type: none"> <li>▪ Cyclist loss of control</li> </ul>
<b>Probability</b>	Very Unlikely	<ul style="list-style-type: none"> <li>▪ Localised issue;</li> <li>▪ Low-moderate cycle volumes;</li> <li>▪ Low travelling speeds.</li> </ul>
<b>Severity</b>	Minor	<ul style="list-style-type: none"> <li>▪ Low impact speeds of less than 30 km/h</li> </ul>

**Figure 4.4-26 – Gravel/detritus on the cycle lanes**

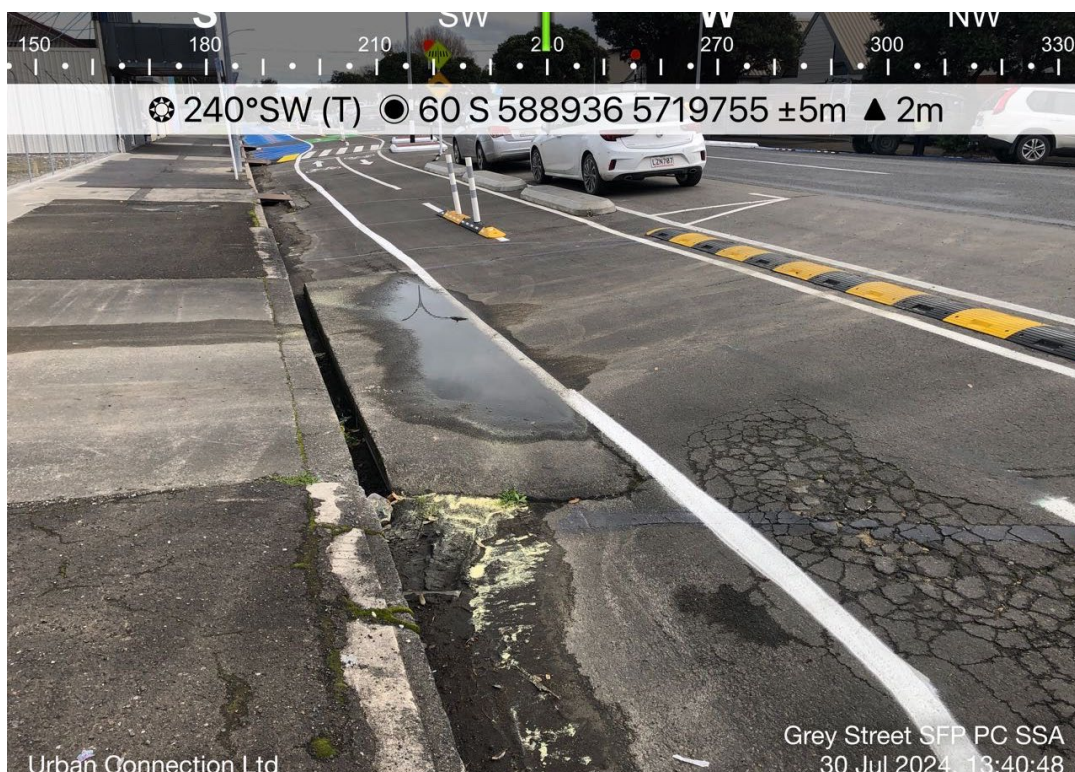
<ul style="list-style-type: none"> <li>▪ Cyclist loss of control</li> </ul>
<b>Probability</b>	Very Unlikely	<ul style="list-style-type: none"> <li>▪ Localised issue;</li> <li>▪ Low-moderate cycle volumes;</li> <li>▪ Low travelling speeds.</li> </ul>
<b>Severity</b>	Minor	<ul style="list-style-type: none"> <li>▪ Low impact speeds of less than 30 km/h</li> </ul>

**Figure 4.4-27 – Ponding adjacent to the cycle lane**

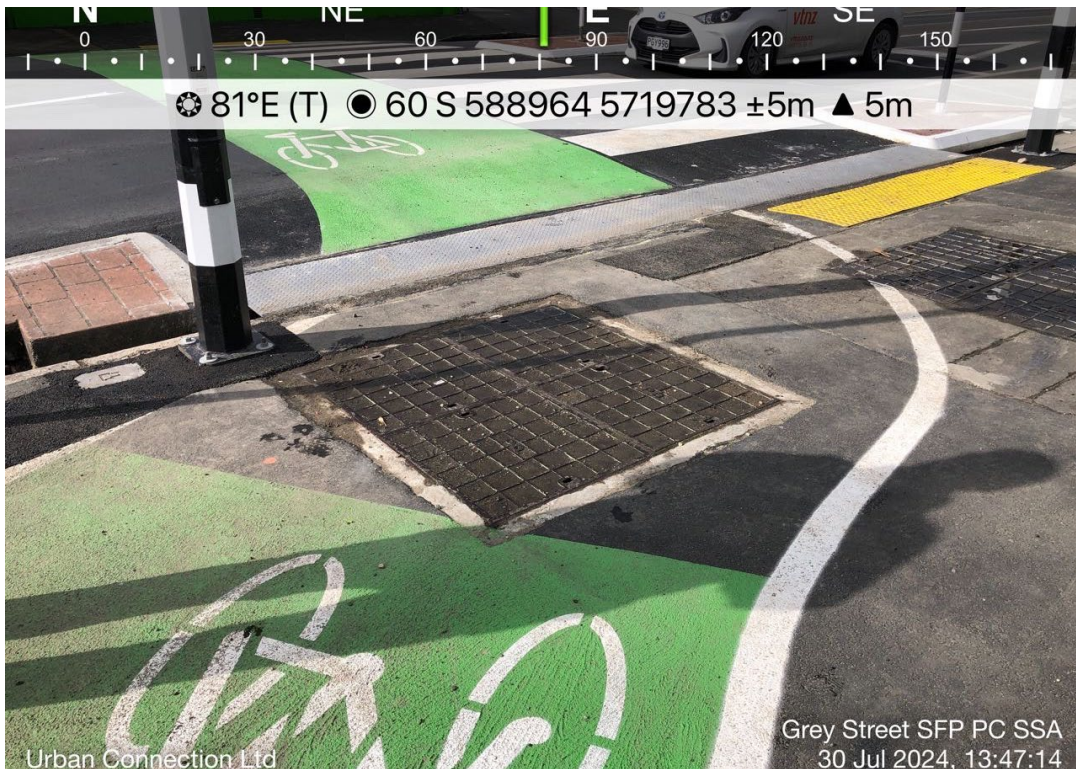
<ul style="list-style-type: none"> <li>▪ Cyclist loss of control</li> </ul>
<b>Probability</b>	Very Unlikely	<ul style="list-style-type: none"> <li>▪ Low-moderate cycle volumes;</li> <li>▪ Low travelling speeds.</li> </ul>
<b>Severity</b>	Minor	<ul style="list-style-type: none"> <li>▪ Low impact speeds of less than 30 km/h</li> </ul>

**Figure 4.4-28 – Manhole cover on the cycleway**

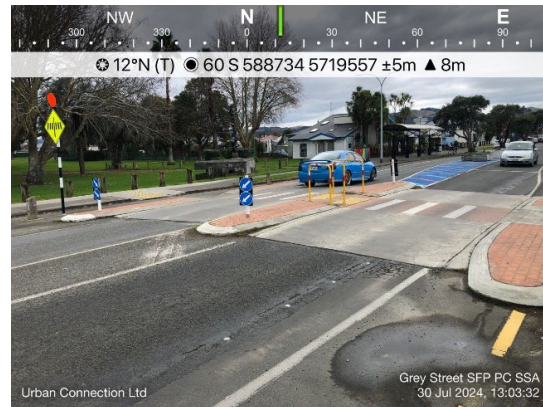
**Figure 4.4-32 – Missing white triangles at raised pedestrian crossing**

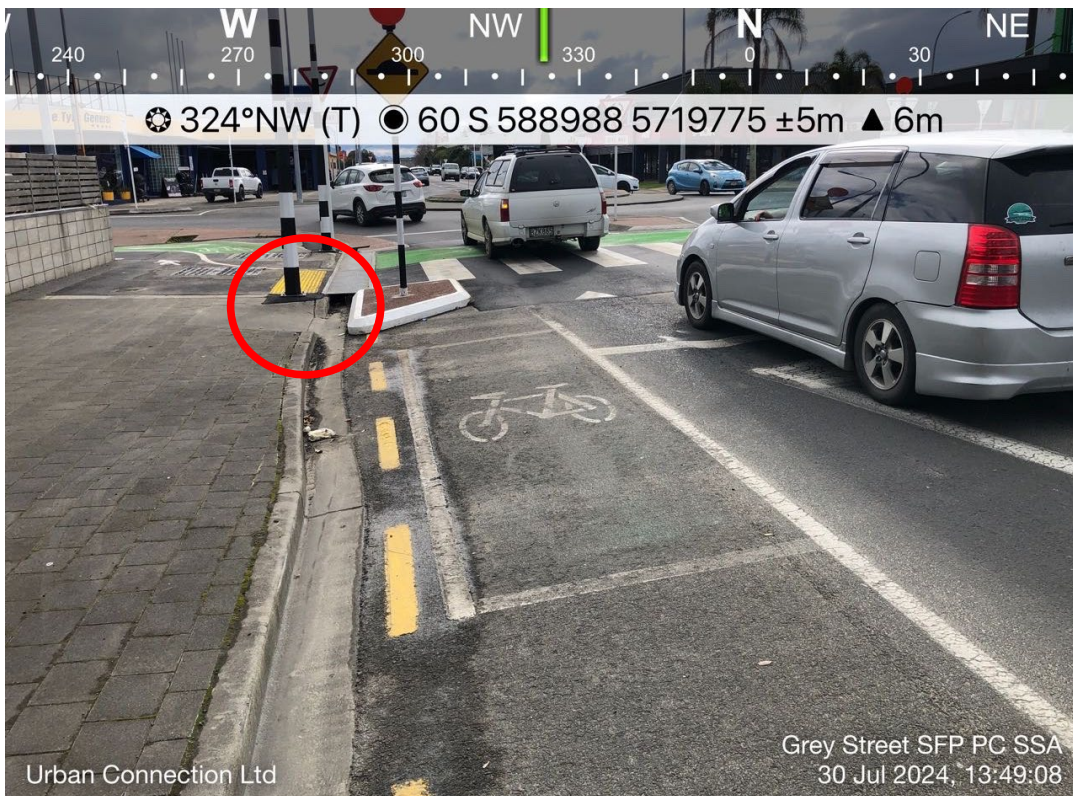
<ul style="list-style-type: none"> <li>Vehicle v cyclist</li> </ul>
Probability	Unlikely	<ul style="list-style-type: none"> <li>Low vehicle approach speeds;</li> <li>Low to moderate cyclist volumes.</li> </ul>
Severity	Minor	<ul style="list-style-type: none"> <li>Impact speeds unlikely to exceed 30 km/h</li> </ul>

Figure 4.4-33 – Cycle connections on Childers Road

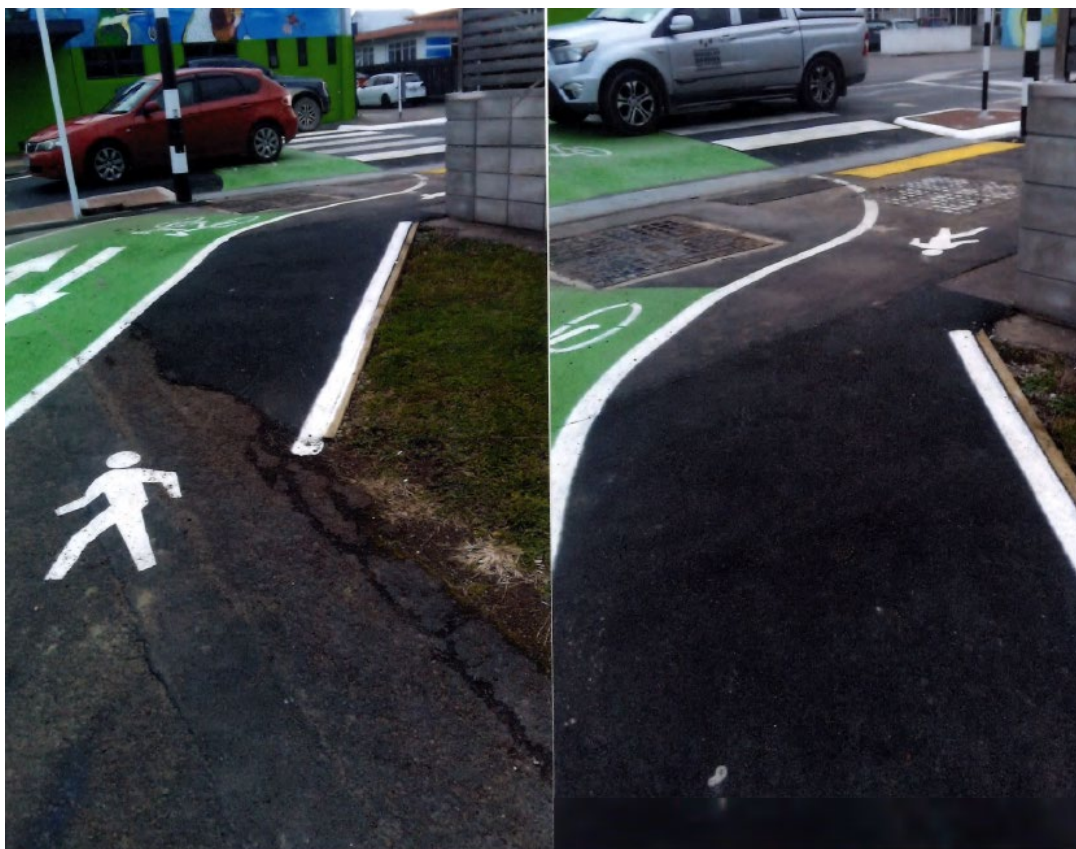
**Figure 4.4-34 – Visibility at the corner (Source: GDC)**

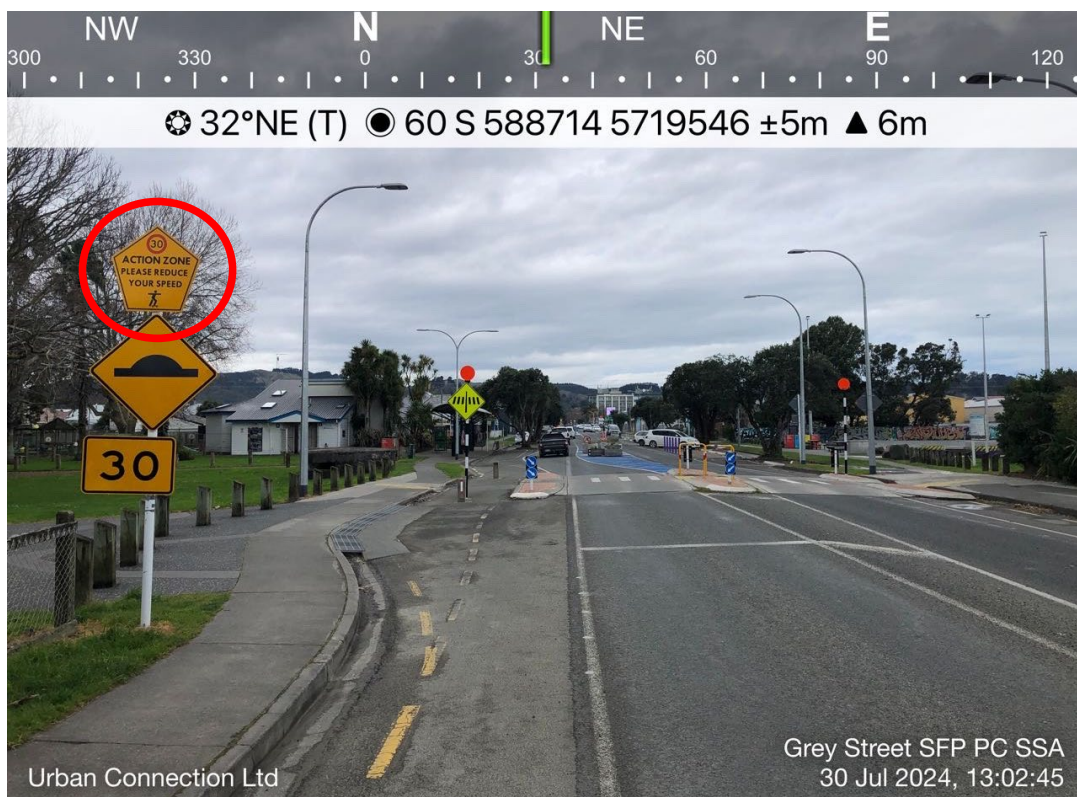
Figure 4.4-35 – Action zone sign with 30 km/h advisory speed

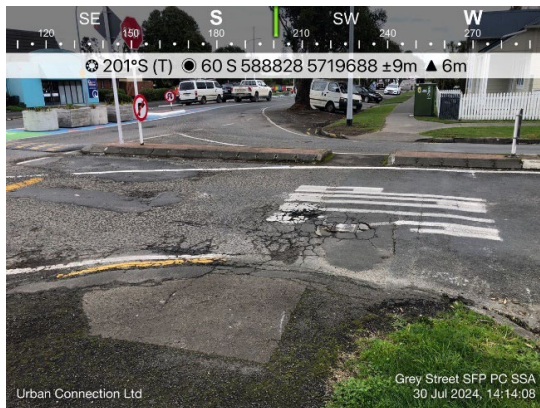
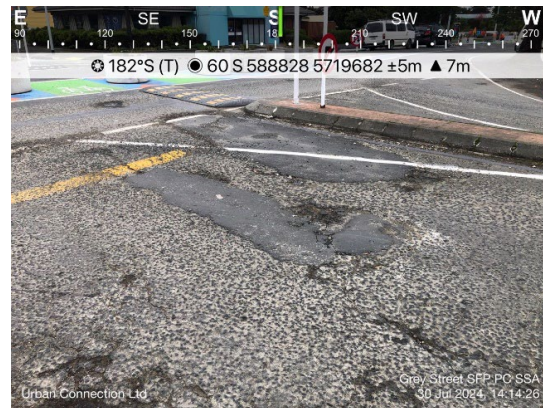
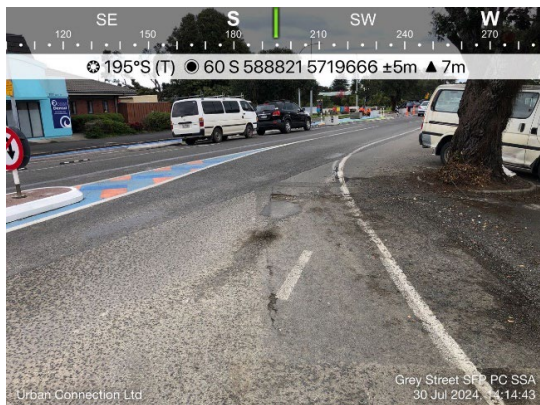
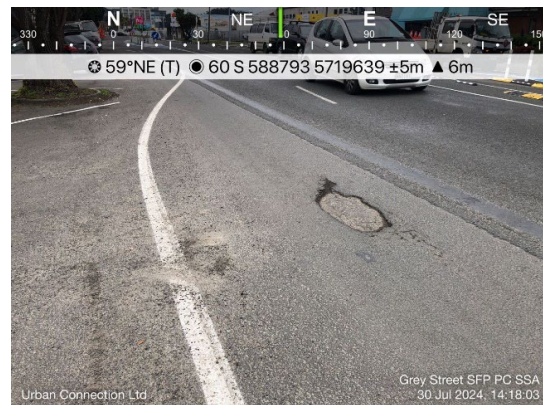
Figure 4.4-36 – Pavement defects

Figure 4.4-37 – Pavement defects

Figure 4.4-38 – Pavement defects

Figure 4.4-39 – Pavement defects

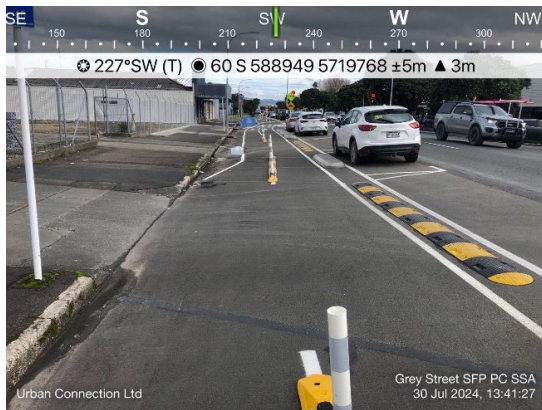
Figure 4.4-40 – No green surfacing through driveway

While most of the driveways that cross through the bidirectional cycleway have green surfacing markings, some driveways do not have such provisions. Green surfacing markings are important delineation features that highlight the interaction with the cycleway and the potential presence of cyclists. A consistent treatment throughout the site is assessed to positively affect the safety of all users.

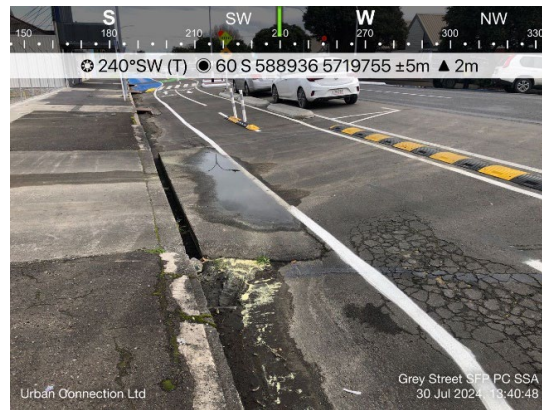
Figure 4.4-41 – No green surfacing through driveway

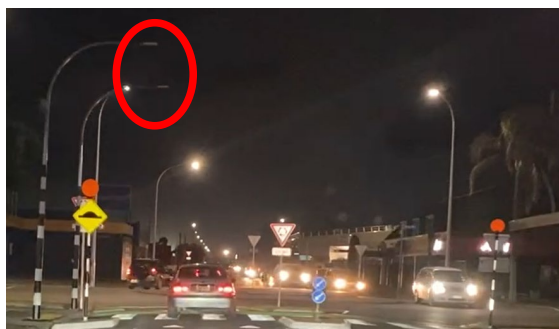
**Figure 4.4-42 – Low-level light not working on Childers Road**

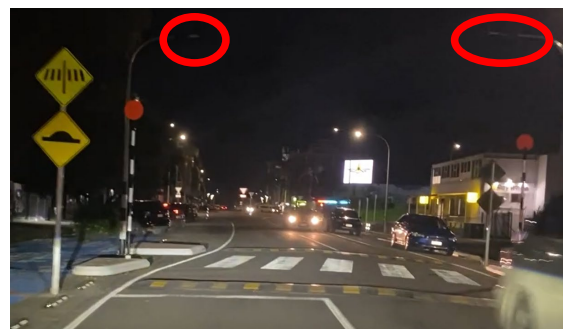
**Figure 4.4-43 – Low-level light not working on Grey Street**

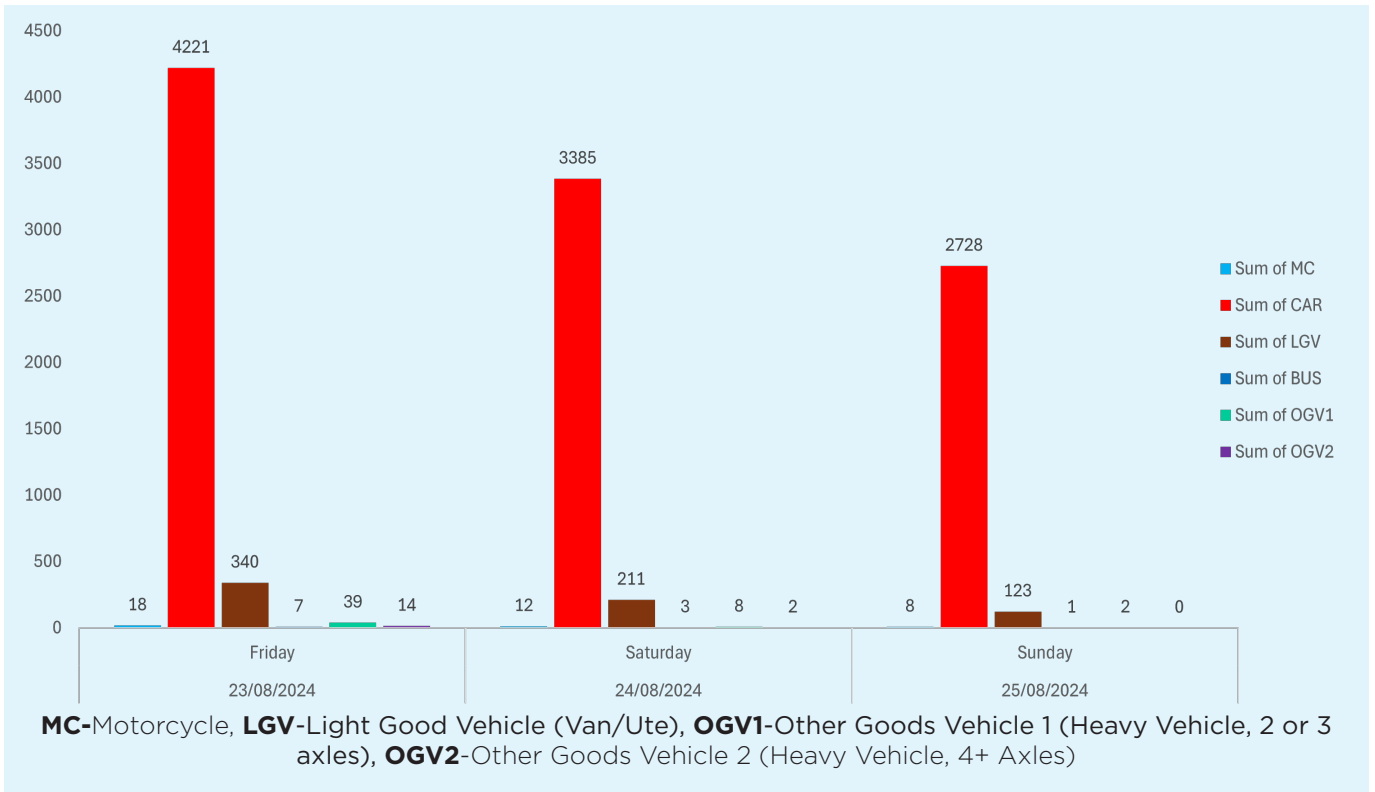
Total volume of motor vehicles passing through the Grey St and Kahutia St Intersection each survey day (7:00am - 5:00pm), categorised by user type.

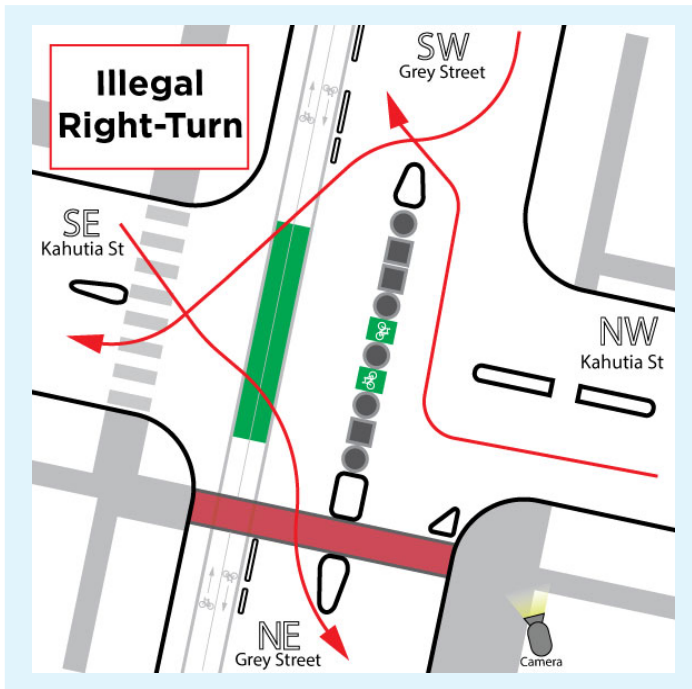
The graphic below shows the movement paths of illegal right-hand turns recorded.

*Illegal right-hand turn movements.*

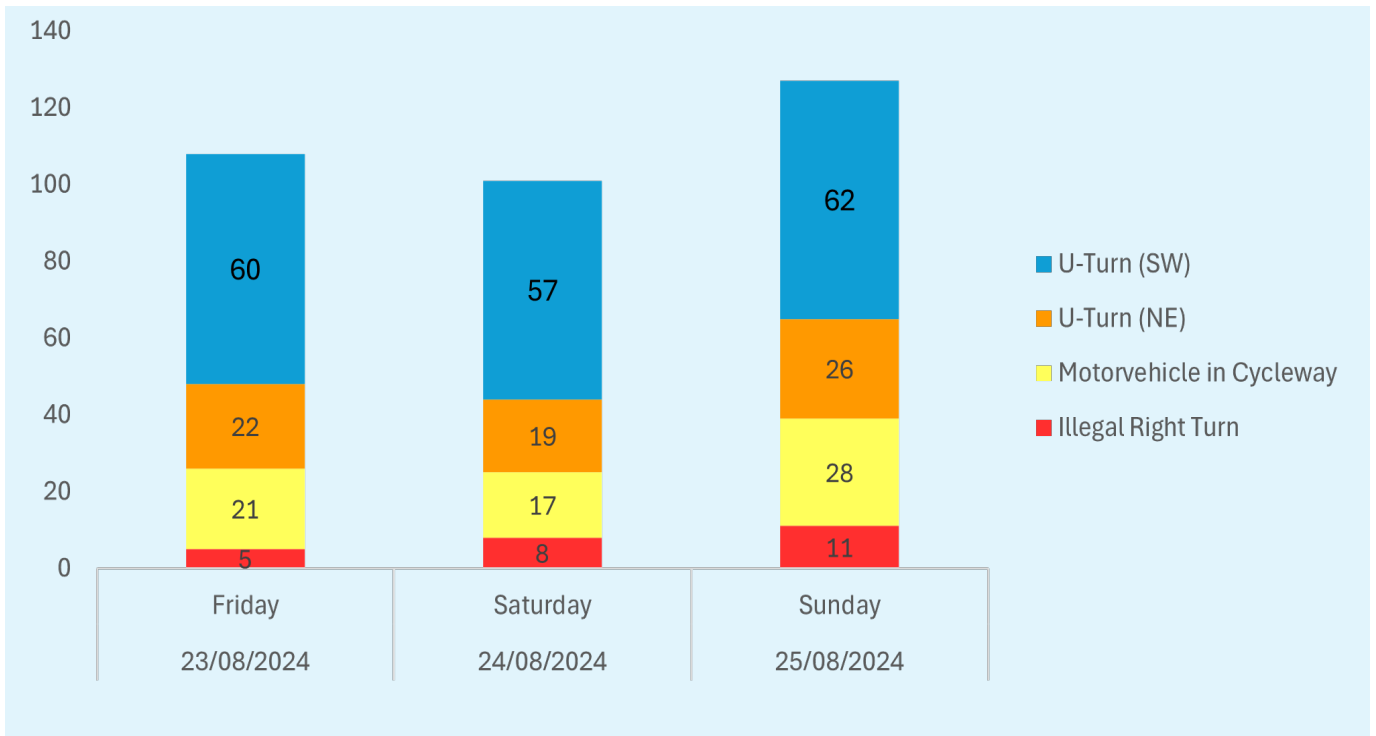
Total volume of motor vehicles completing an illegal movement while travelling through the Grey St/Kahutia St intersection for each survey day (7:00am - 5:00pm), categorised by movement type. Note that some vehicles were counted twice, completing a U-turn and travelling in the cycleway.

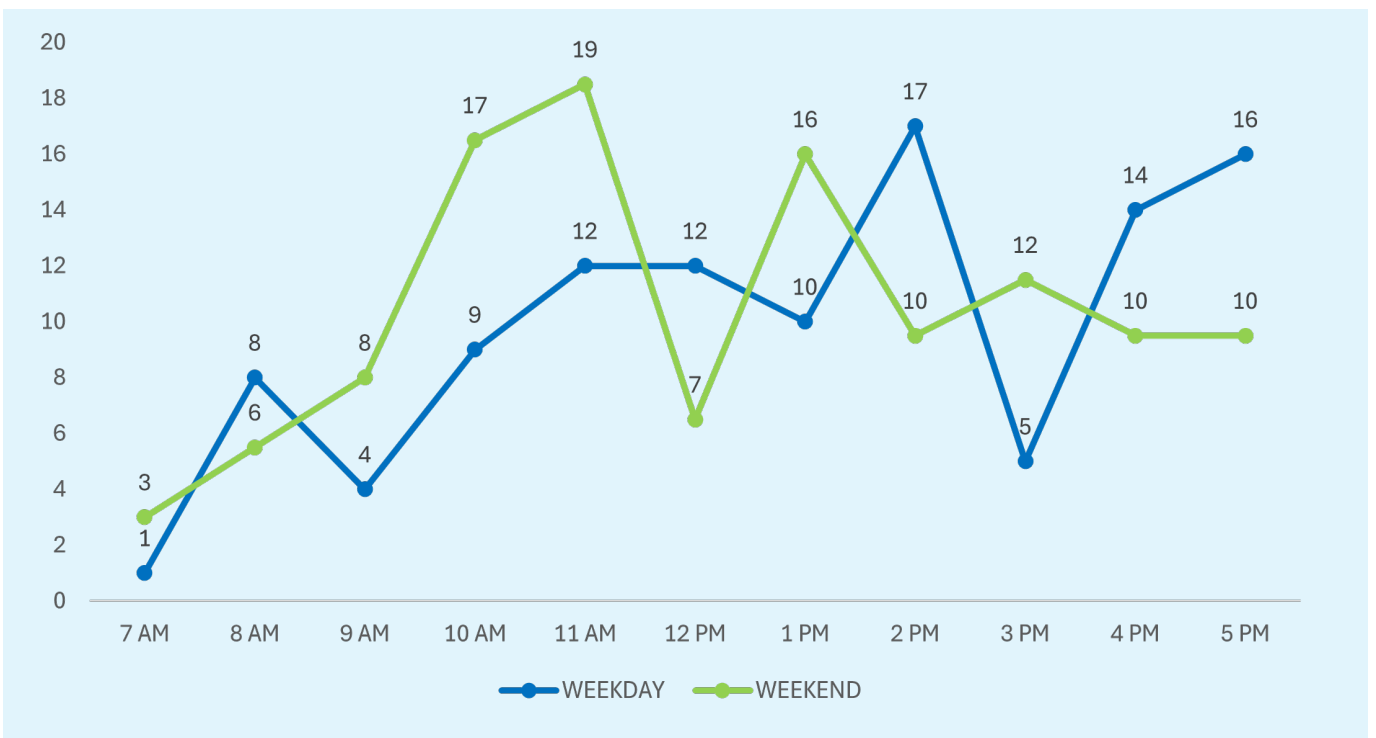
Average hourly volumes of motor vehicles completing illegal movements, passing through the Grey St and Kahutia St Intersection on a weekday compared to a weekend day. Weekday volumes are from Friday 23rd August and weekend volumes an average of the 2 weekend days studied.

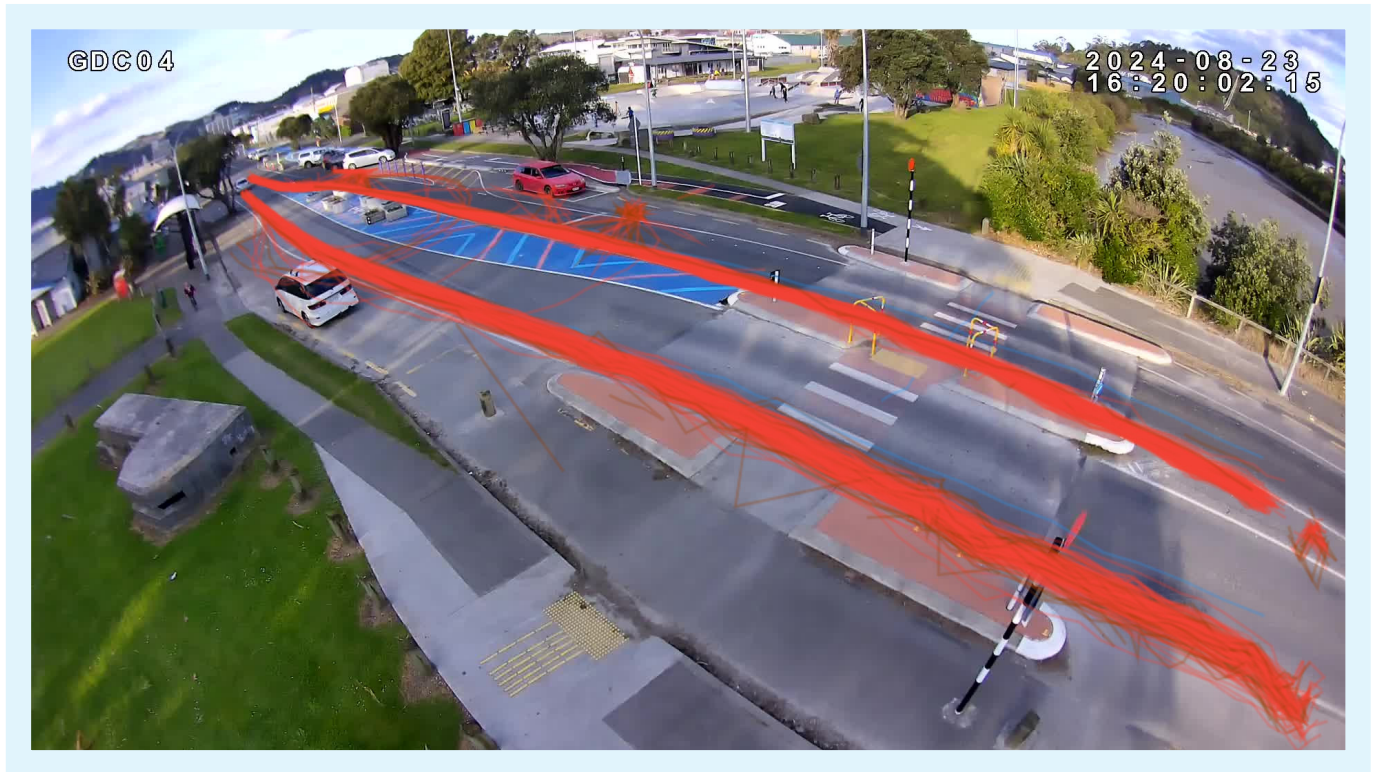
## Weekday Evening - Small Vehicle Movement Traceline Paths

Path tracelines showing the path of motorcycles (blue lines), cars (red lines), and LGVs (brown lines) from 4:20pm - 5:20pm on Friday 23rd August 2024.

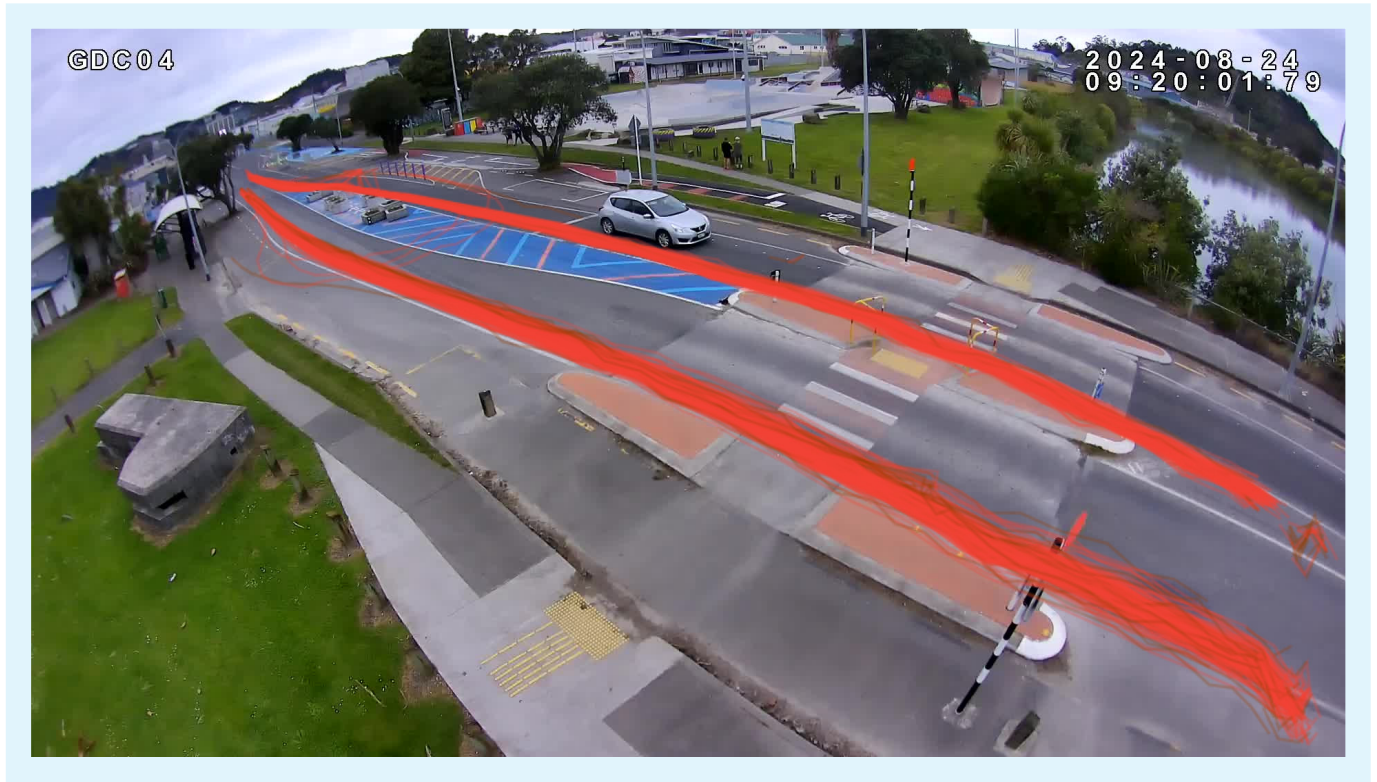
## Weekend - Small Vehicle Movement Traceline Paths

Path tracelines showing the path of motorcycles (blue lines), cars (red lines), and LGVs (brown lines) from 9:20am - 10:20am on Saturday 24th August, 2024.

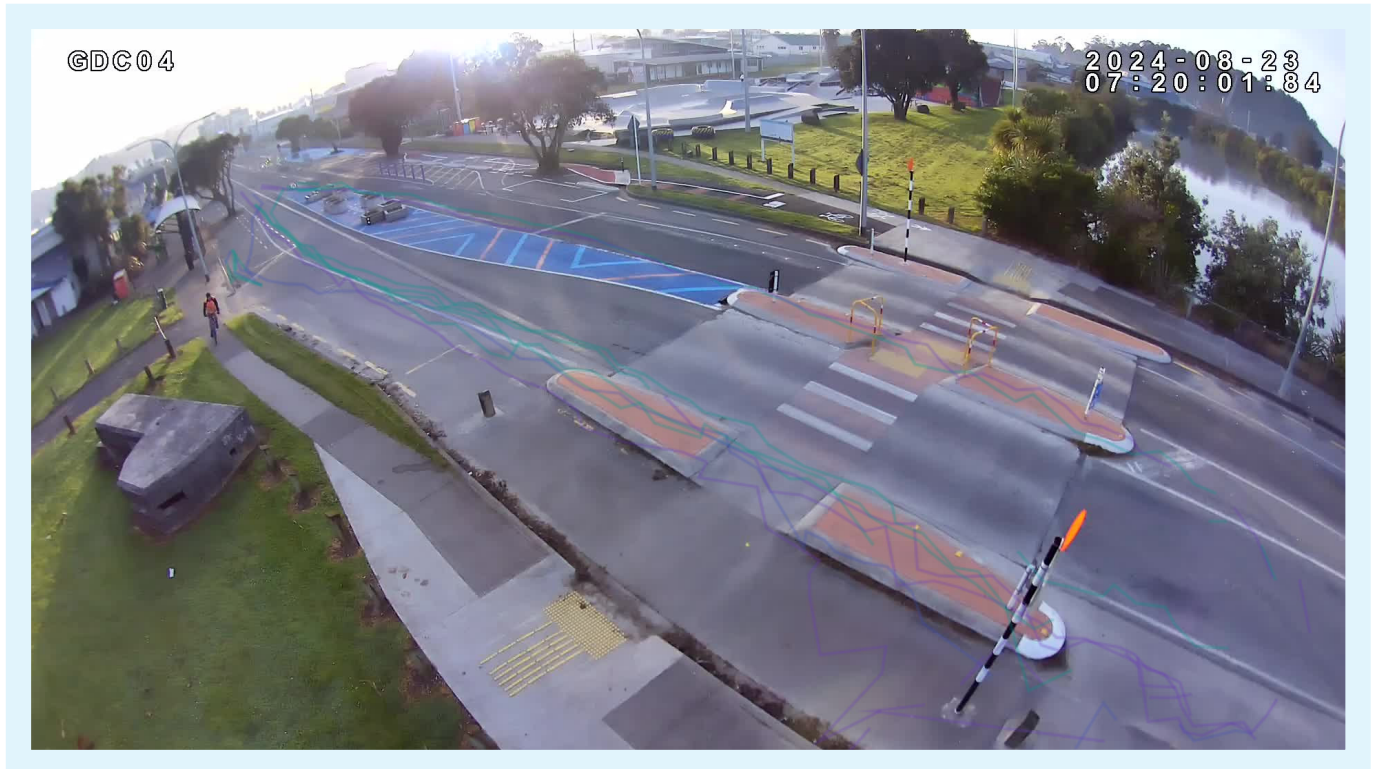
## Weekday Morning - Large Vehicle Movement Traceline Paths

Path tracelines showing the path of buses (blue lines), box trucks (aqua lines), and semi-trailers (purple lines) from 7:20am - 8:20am on Friday 23rd August 2024.

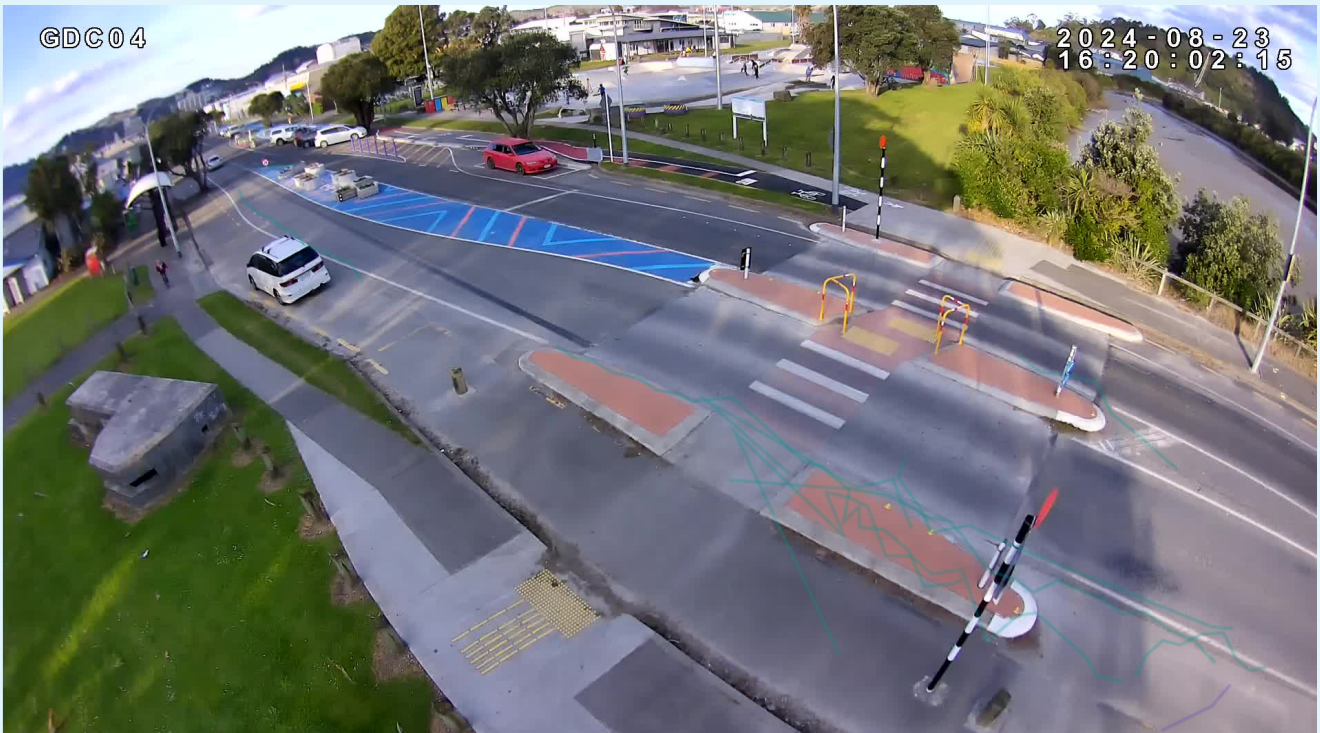
## Weekday Evening - Large Vehicle Movement Traceline Paths

Path tracelines showing the path of buses (blue lines), box trucks (aqua lines), and semi-trailers (purple lines) from 4:20pm - 5:20pm on Friday 23rd August 2024.
