**EXTRAORDINARY COUNCIL/TE KAUNIHERA**  
DATE: Wednesday 6 November 2024  
TIME: 9:00AM  
AT: Te Ruma Kaunihera (Council Meeting Room), Awarua, Fitzherbert Street, Gisborne

24-314

**Grey Street, Gisborne – Streets For People**  
**Post-Construction Stage Safe System Audit Report**  
**Prepared for Gisborne District Council**

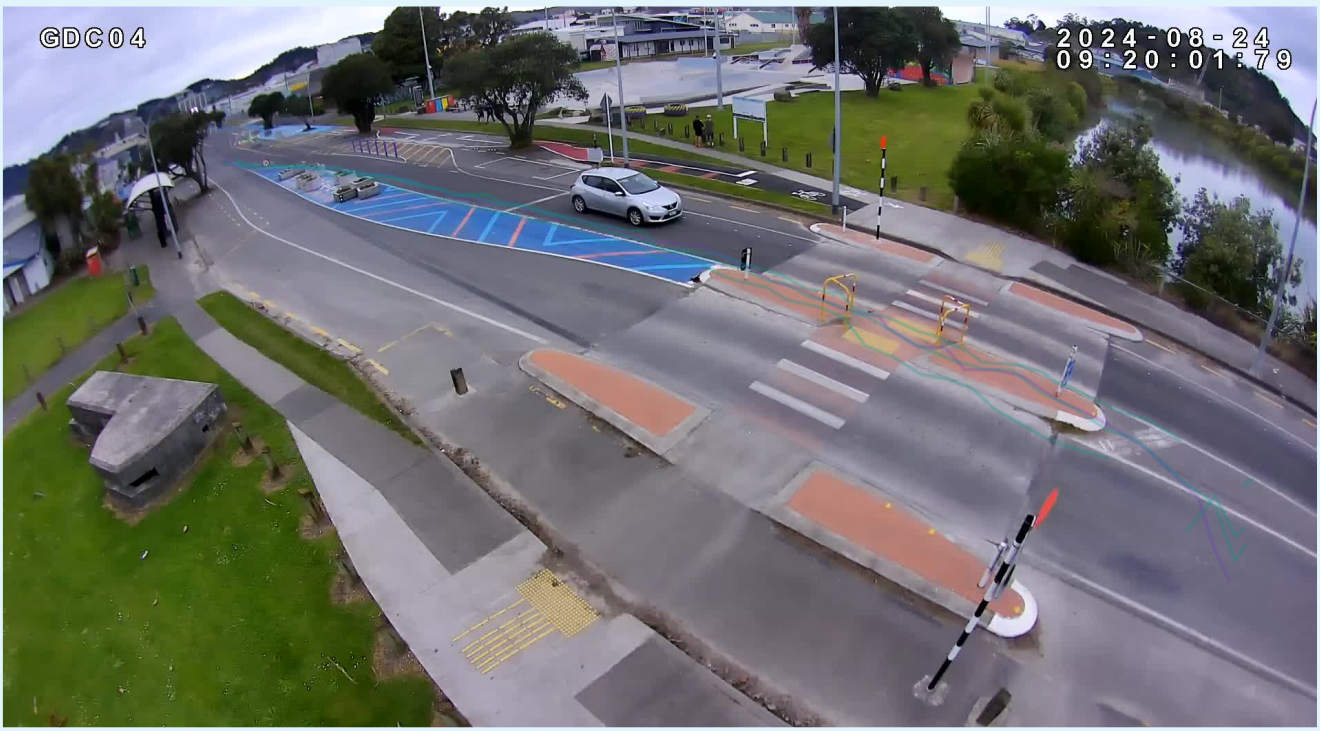
## Weekend - Large Vehicle Movements - Traceline Paths

Path tracelines showing the path of buses (blue lines), box trucks (aqua lines), and semi-trailers (purple lines) from 9:20am - 10:20am on Saturday 24th August, 2024.

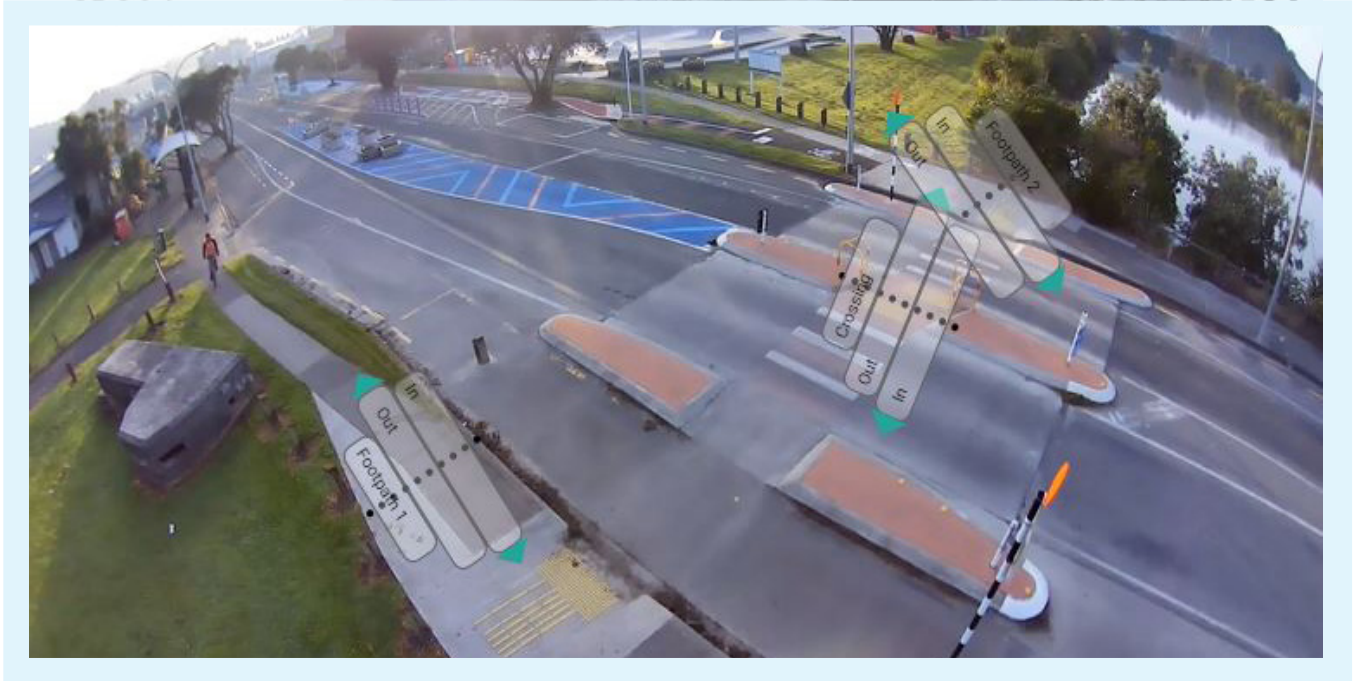
To extract data from the AI Software, we have placed digital 'countlines' over the footage. The AI Software automatically counts any crossing user that passes through those lines. This allows us to study each crossing movement by road user type (pedestrian or bike rider).

Above is a screenshot of how these count lines have been created in the AI Software to extract the relevant data. Each movement studied has a 'Movement Label'.

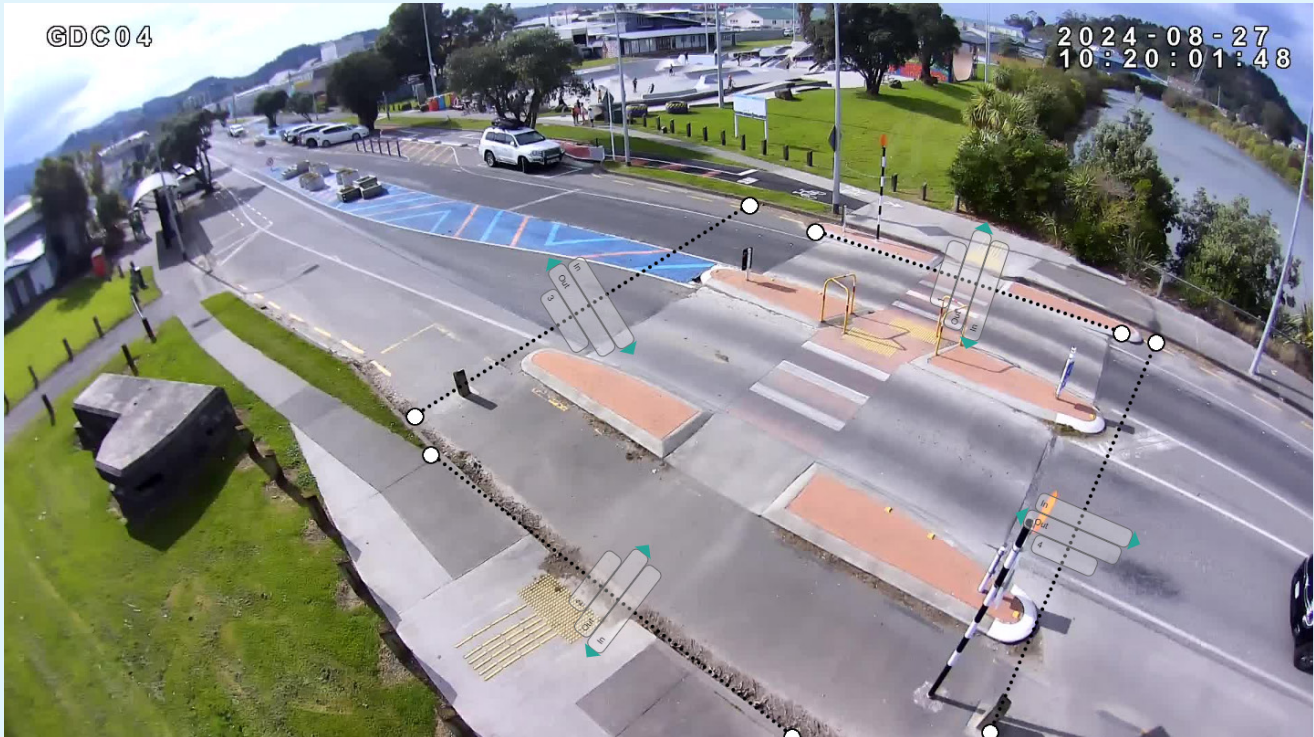
Road user behaviour when pedestrians, bike riders and scooter riders cross the pedestrian crossing on Grey Street.

A set of countlines captures the exact time all crossing users enter the crossing from either side. A second set of count lines captures the exact time a road user enters the described 'conflict zone'.

Bicycle Network reviewed all crossings that occurred during peak hours where the following condition was met: A crossing user entered the crossing within 2 seconds of a road user entering the 'conflict zone' shown on the previous page.

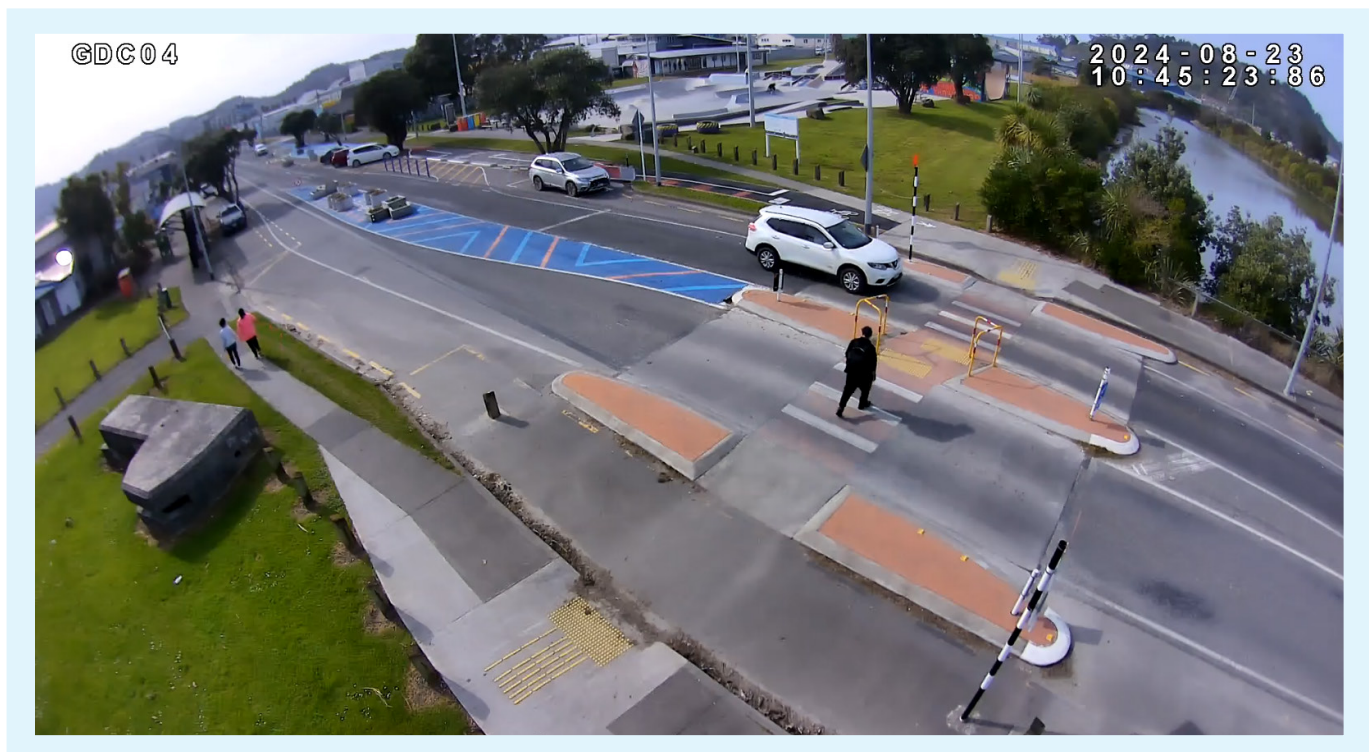
Image showing pedestrian using the crossing as a vehicle continues without stopping (See video clip #1).
