In the matter of An application by NZHG Gisborne Limited to construct eight dwellings and create an eight-lot fee simple subdivision of the property at 99A Stanley Road, Gisborne and pursuant to Regulation 10 of the National Environmental Standard for Assessing and Managing Contaminants in Soil to Protect Human Health

**STATEMENT OF EVIDENCE OF JASON STRONG
FOR NZHG GISBORNE LIMITED**

**99A STANLEY ROAD
GISBORNE**

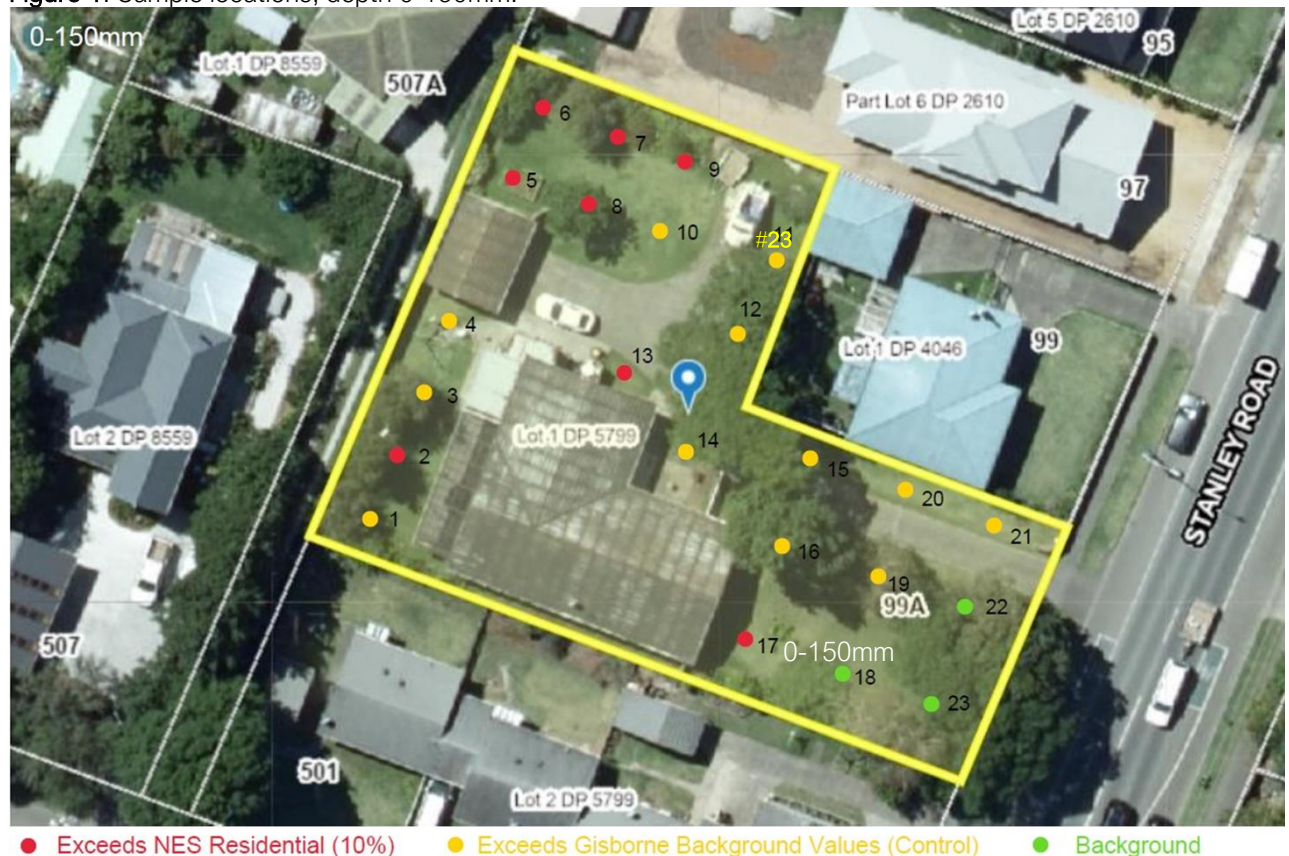
Figure 1. Sample locations, depth 0-150mm.

The location of these samples are shown in Figures 1, 2, 3, and 4.

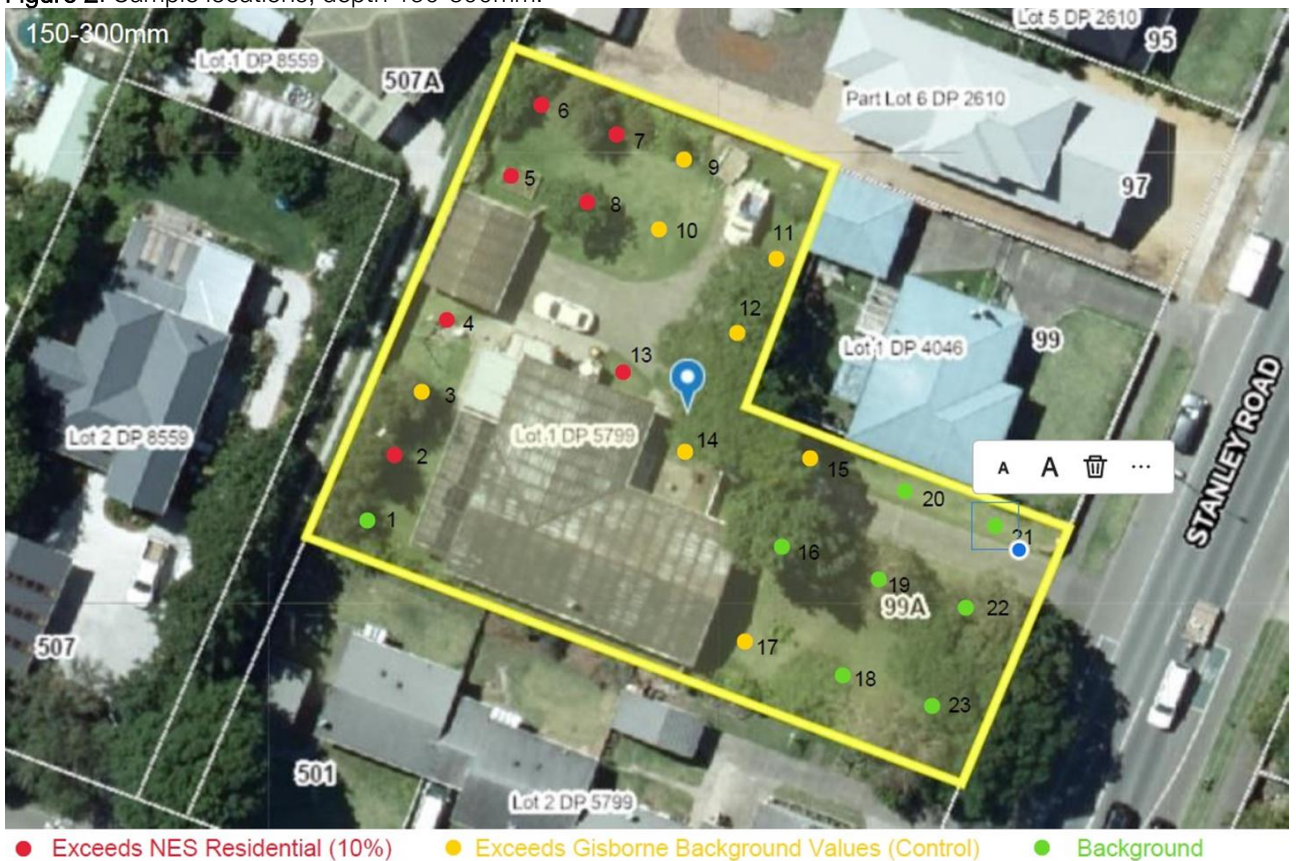
Figure 2. Sample locations, depth 150-300mm.

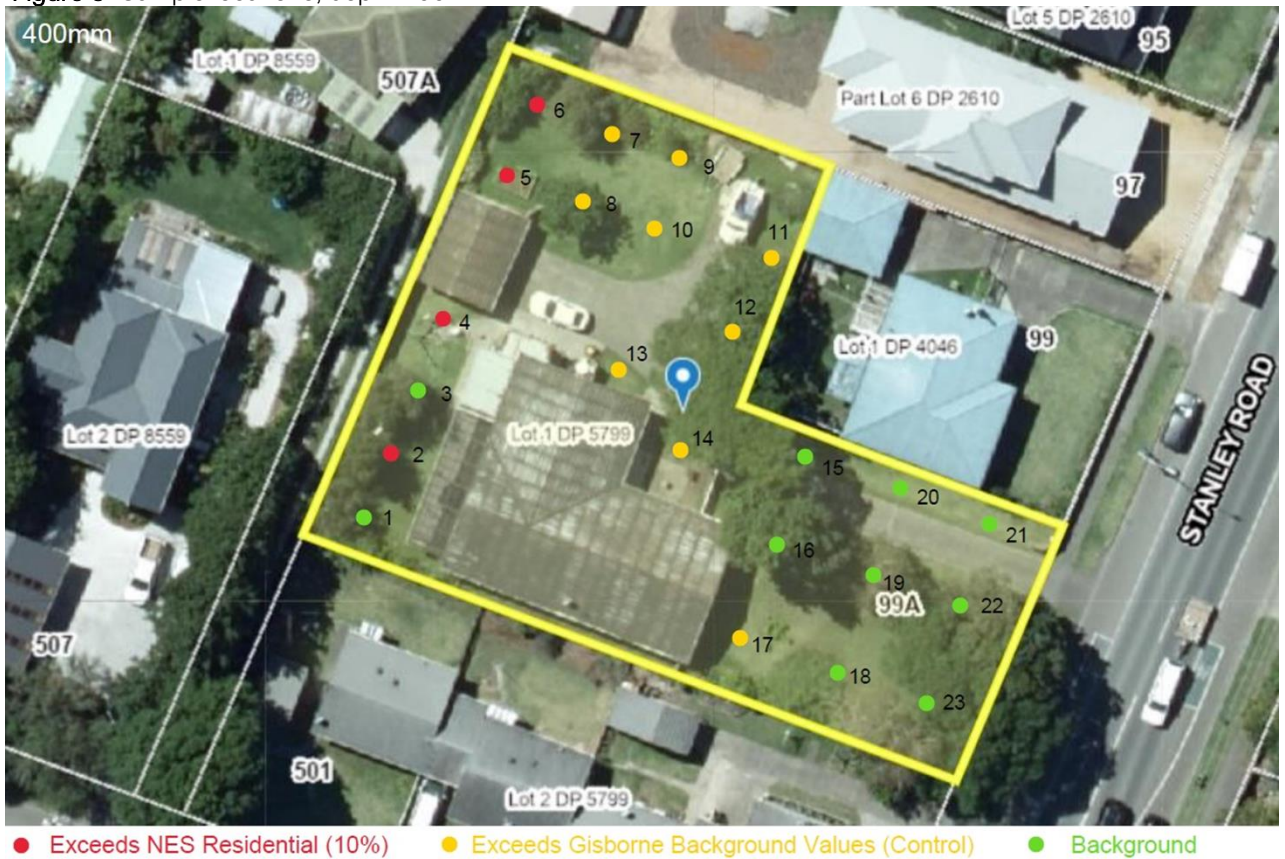
Figure 3. Sample locations, depth 400mm.

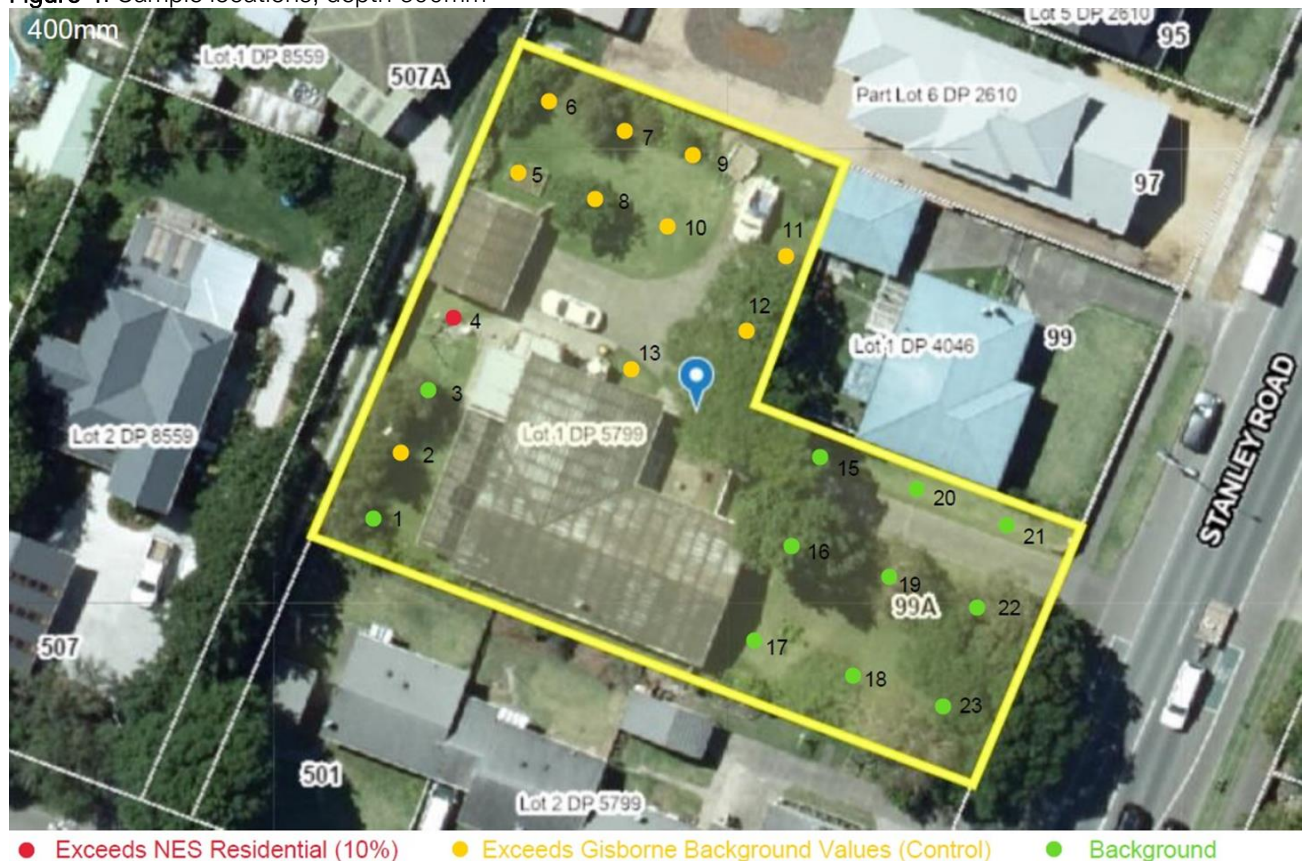
Figure 4. Sample locations, depth 500mm

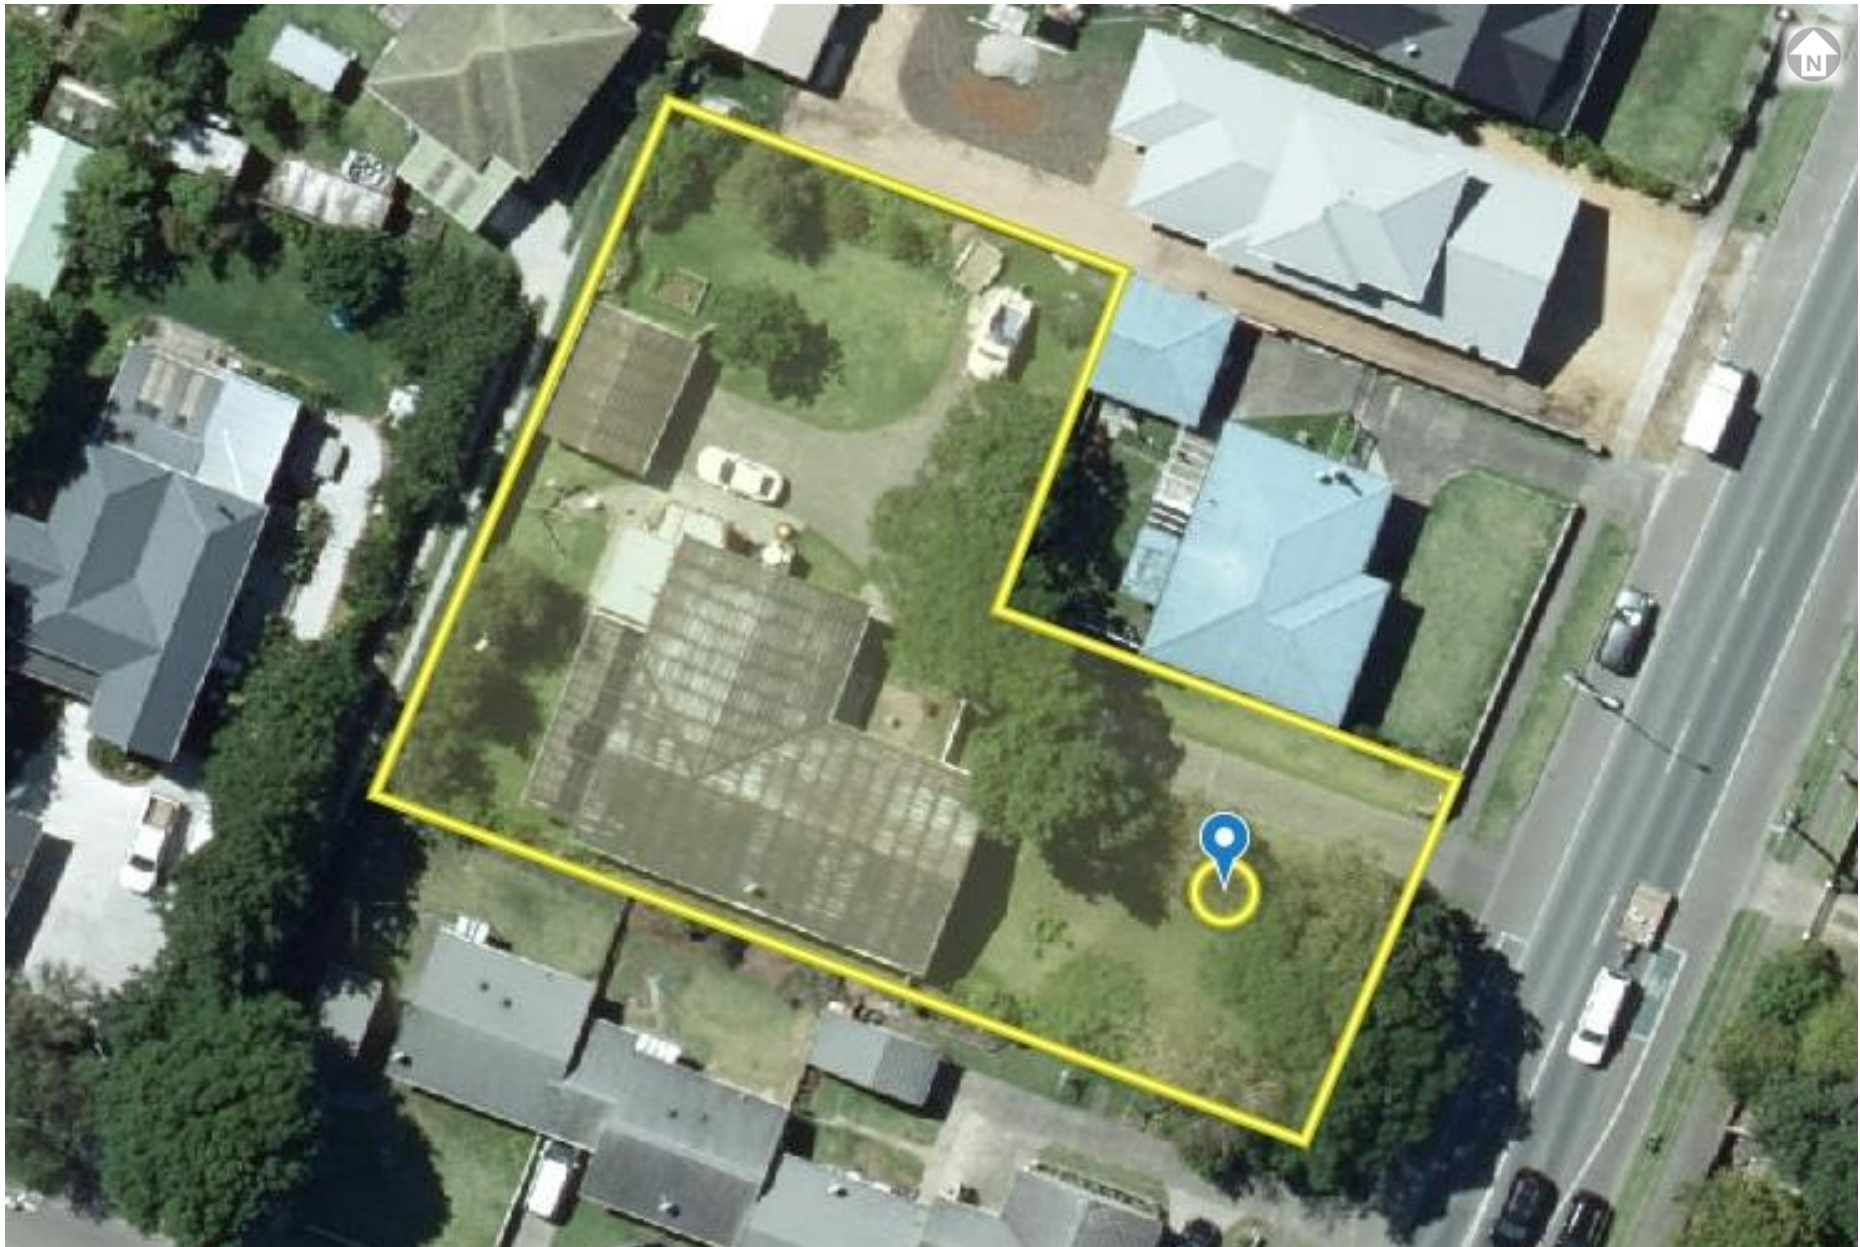
FIGURE 1. SITE LAY OUT PLAN FOR 99a STANLEY ROAD, GISBORNE

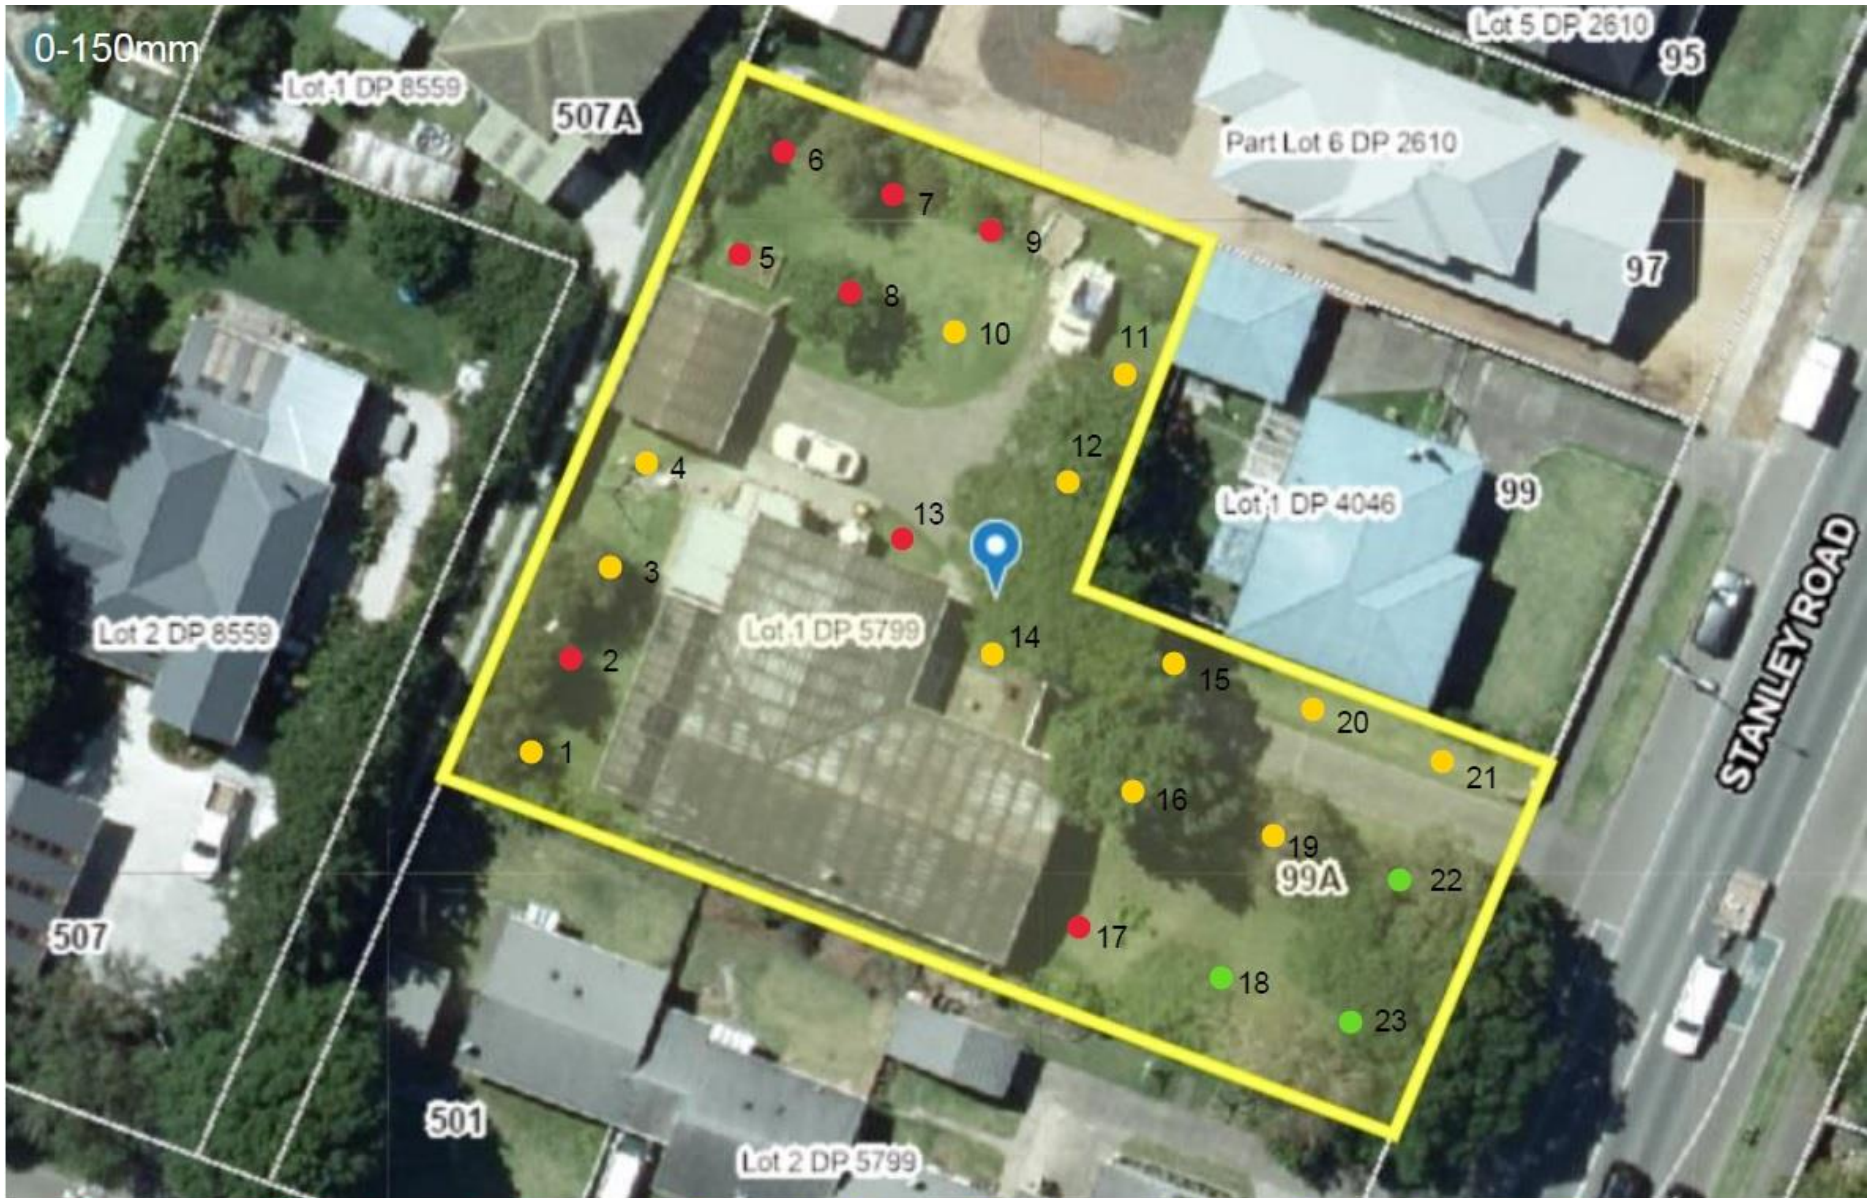
FIGURE 3. SAMPLE LOCATIONS 0-150mm DEPTH

● Exceeds NES Residential (10%) ● Exceeds Gisborne Background Values (Control) ● Background

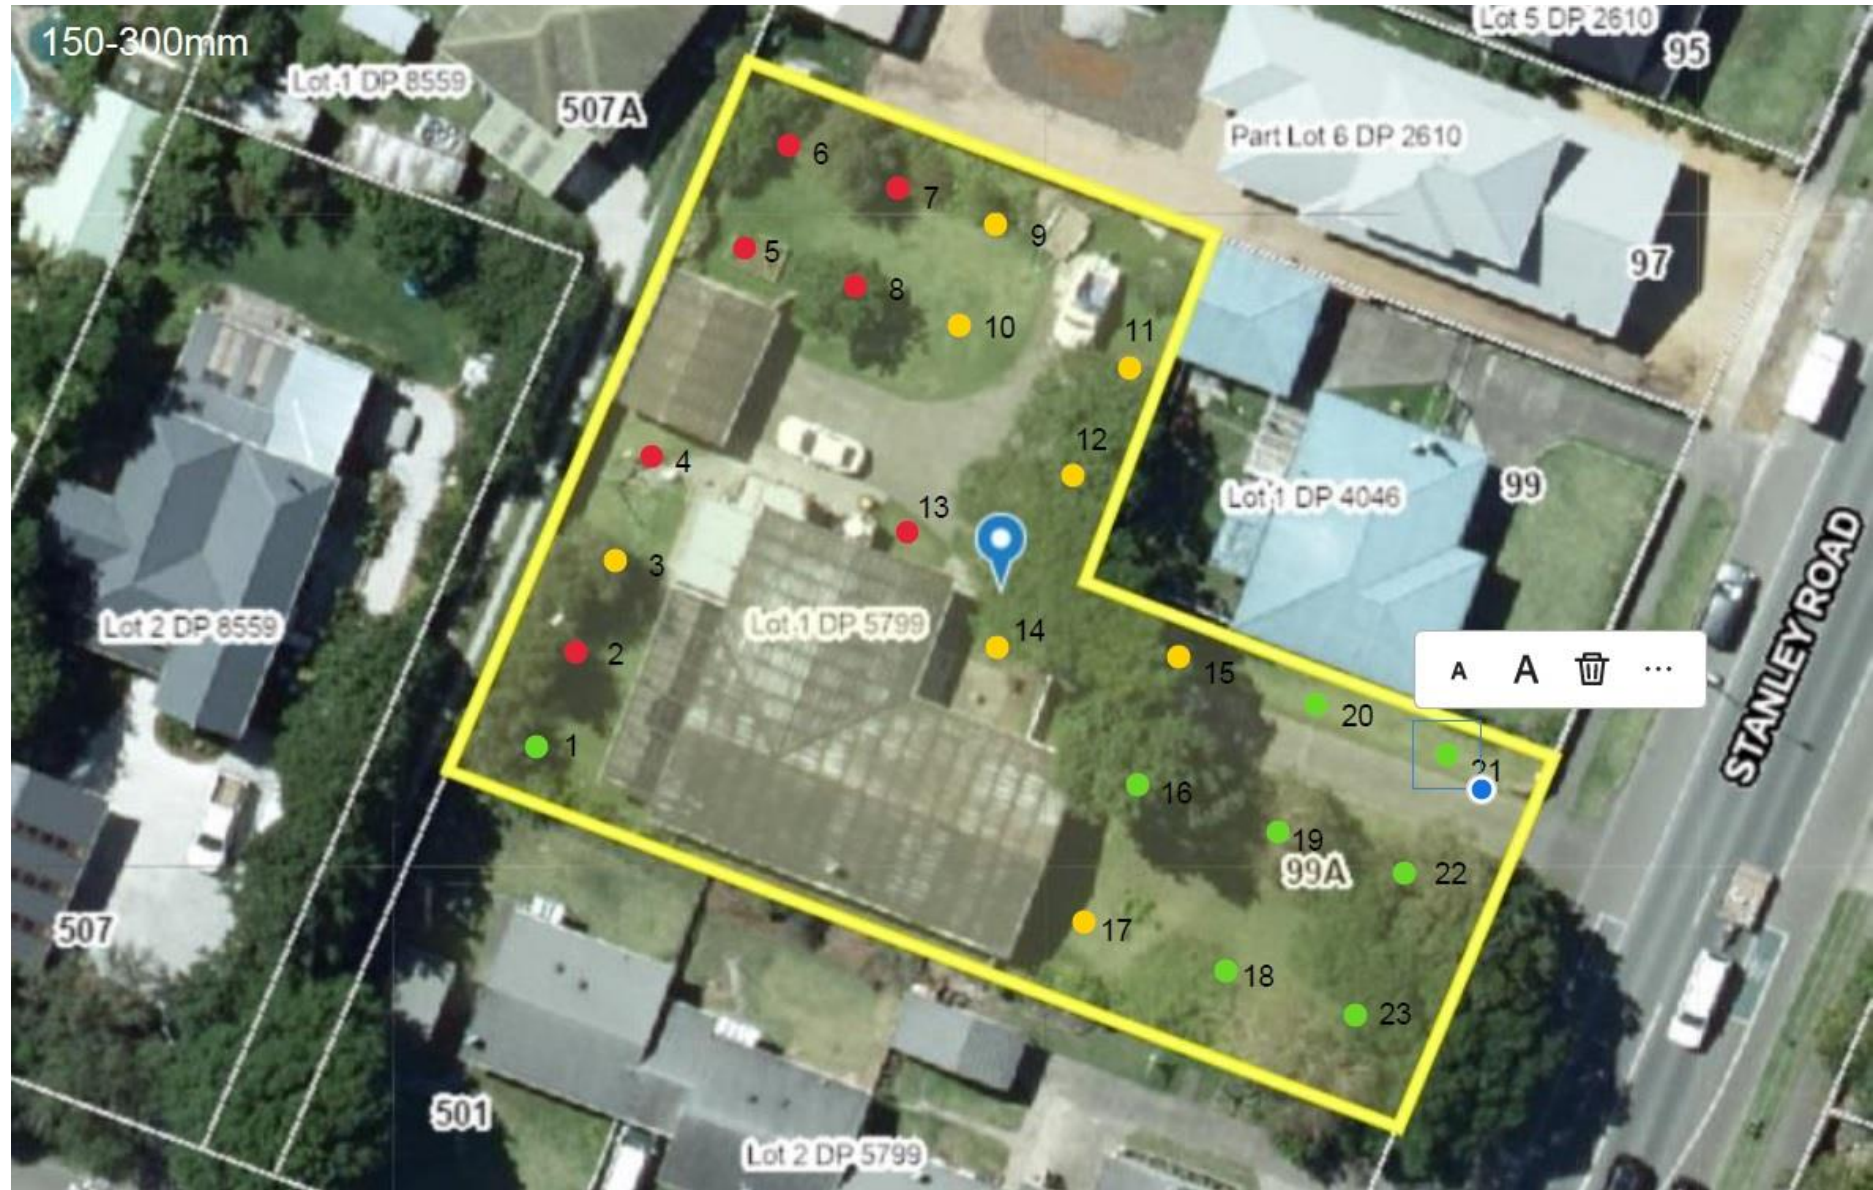
FIGURE 4. SAMPLE LOCATIONS 150-300mm DEPTH

- Exceeds NES Residential (10%)
- Exceeds Gisborne Background Values (Control)
- Background

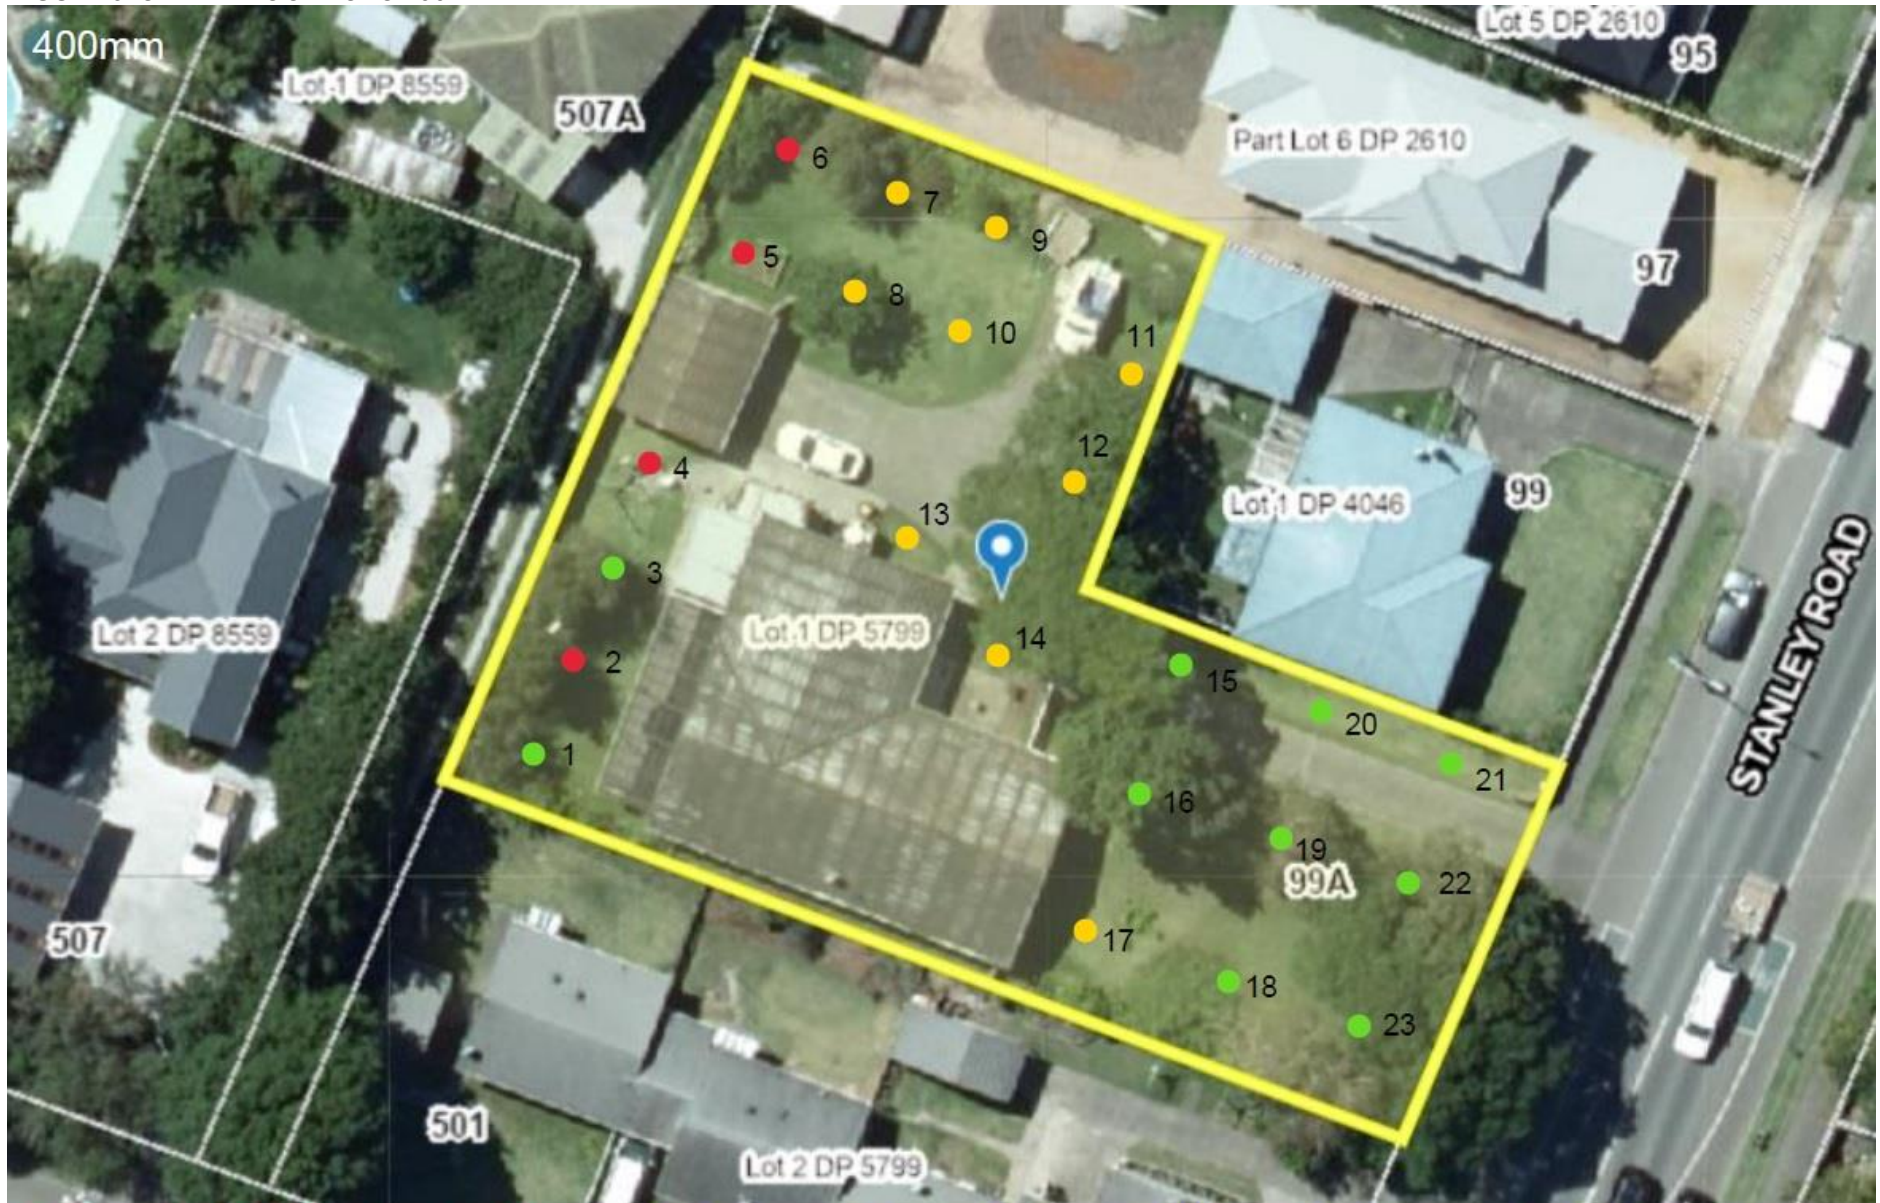
FIGURE 5. SAMPLE LOCATIONS 400mm DEPTH

- Exceeds NES Residential (10%)
- Exceeds Gisborne Background Values (Control)
- Background

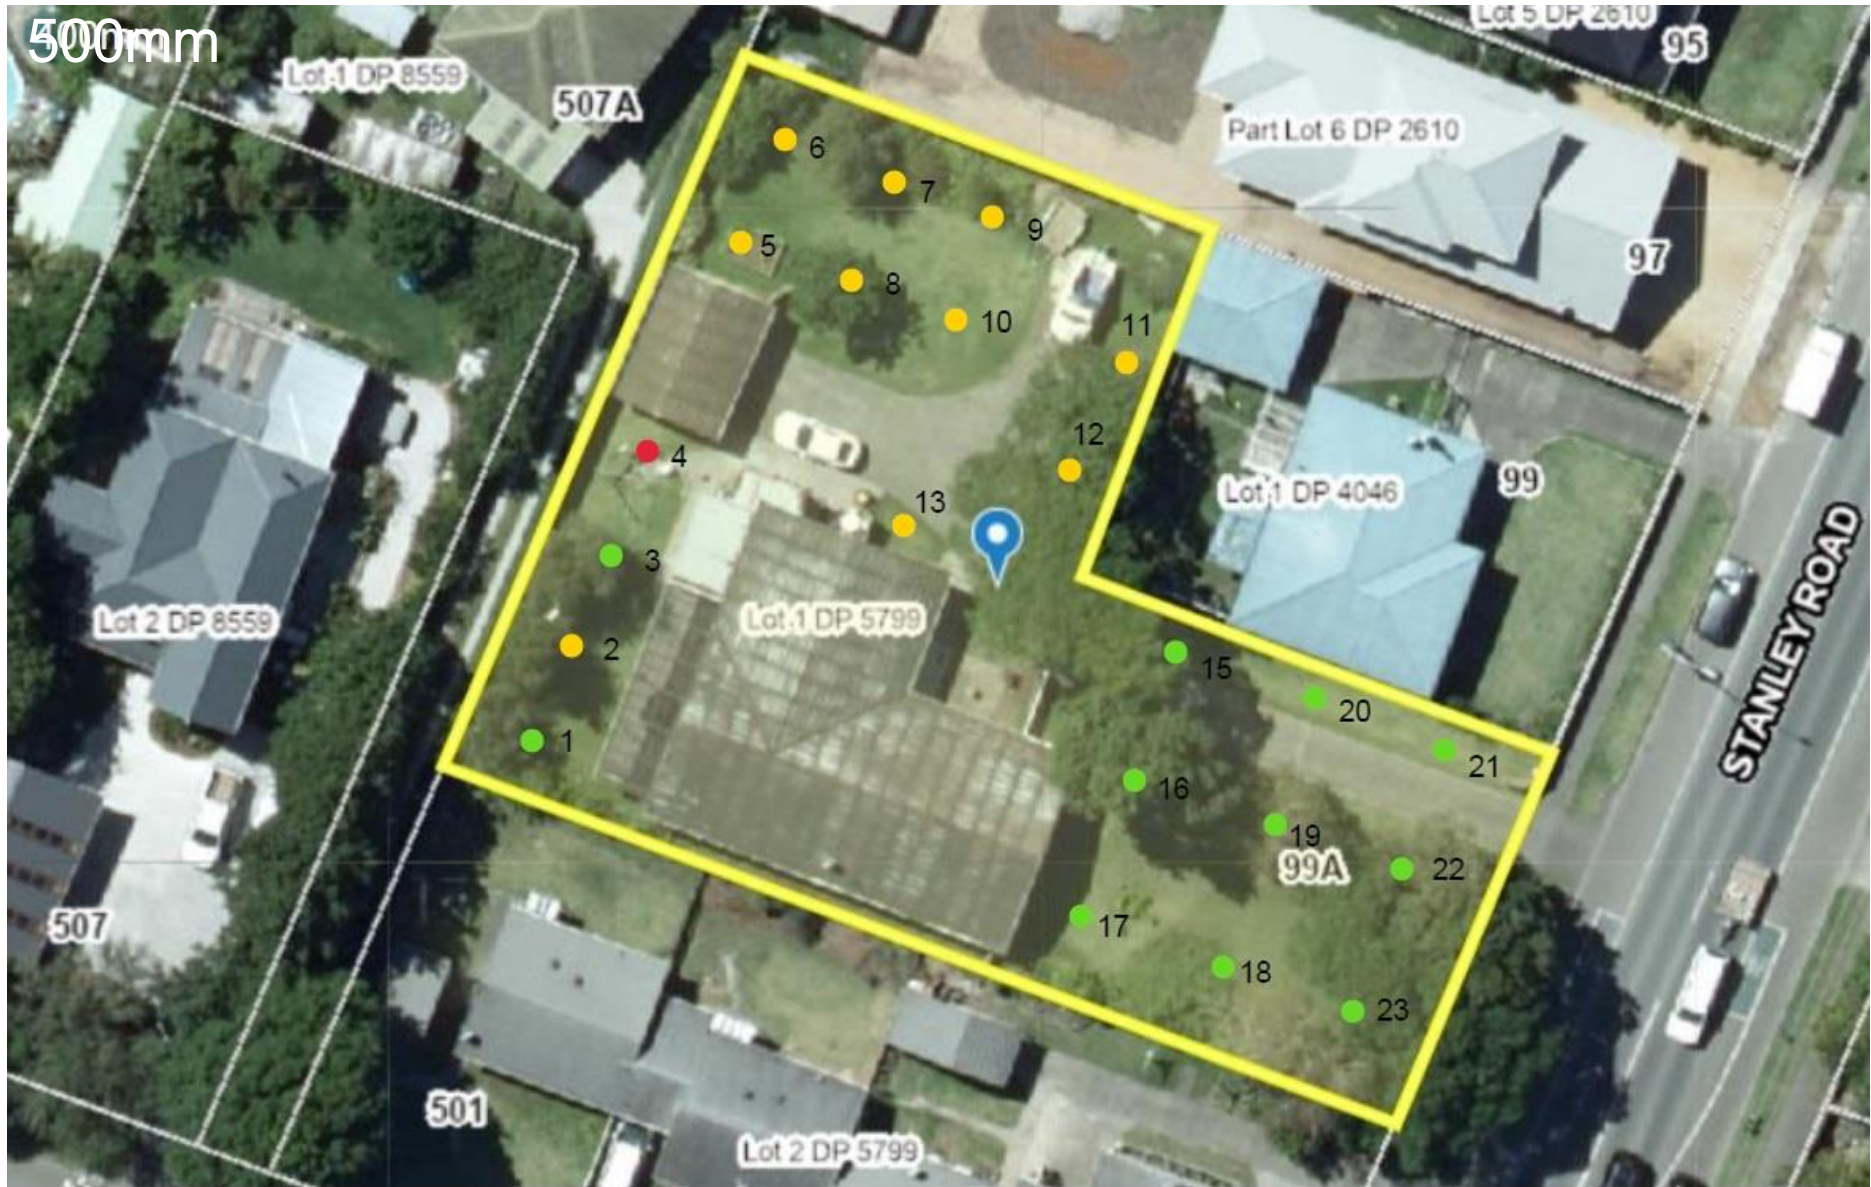
FIGURE 6. SAMPLE LOCATIONS 500mm DEPTH

- Exceeds NES Residential (10%)
- Exceeds Gisborne Background Values (Control)
- Background

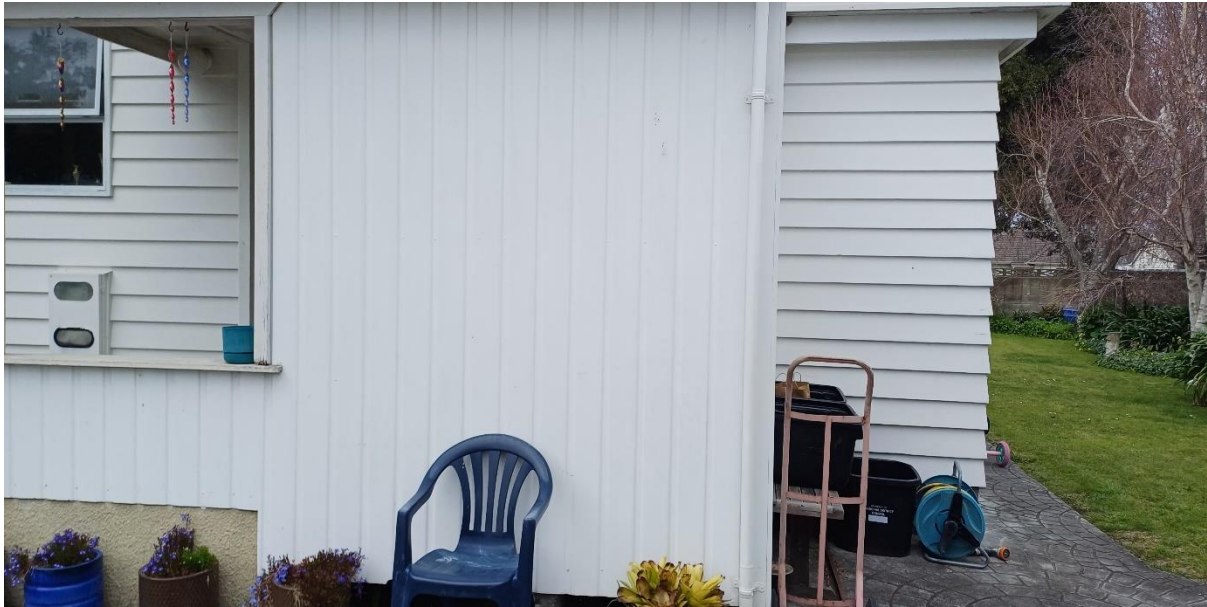
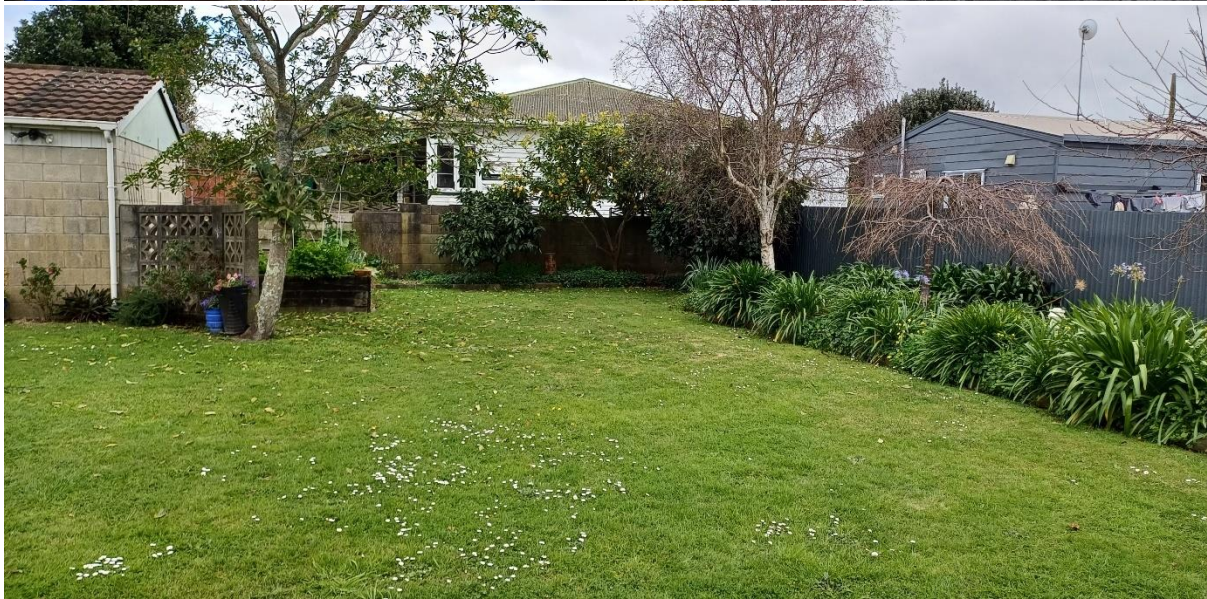
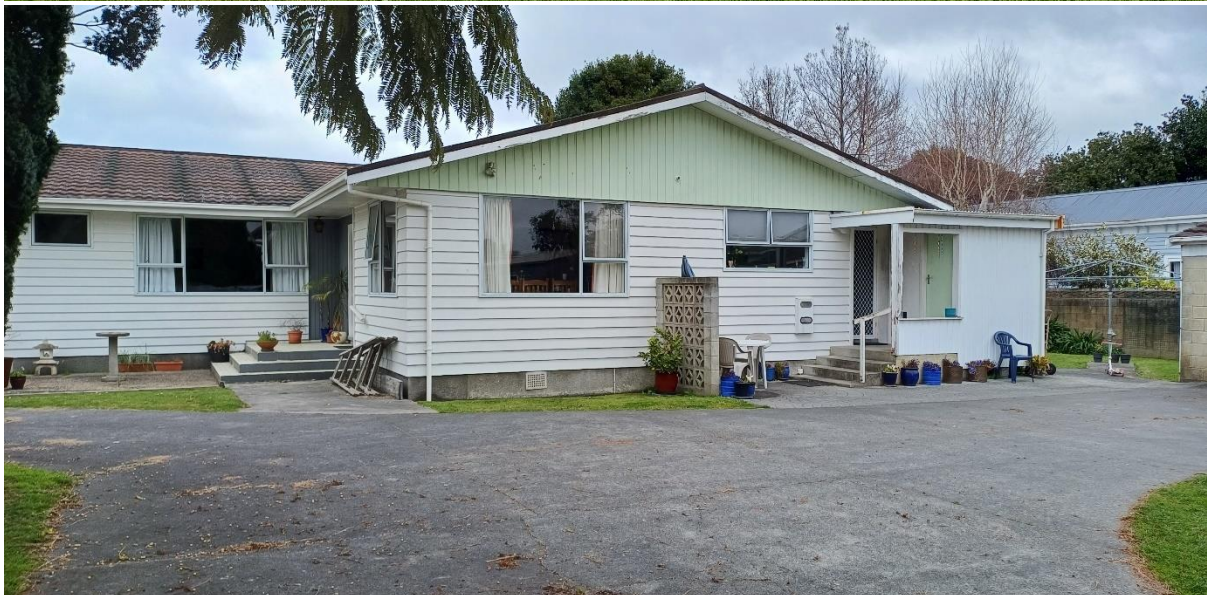
Top. Asbestos construction on porch **Middle.** Northern side of property. **Bottom.** North facing side of house.
