TE ARA TIPUNA TRAIL – GISBORNE TO
OPOTIKI

GEOTECHNICAL ASSESSMENT REPORT

INITIA REF P-001538 REV 2

JUNE 2023

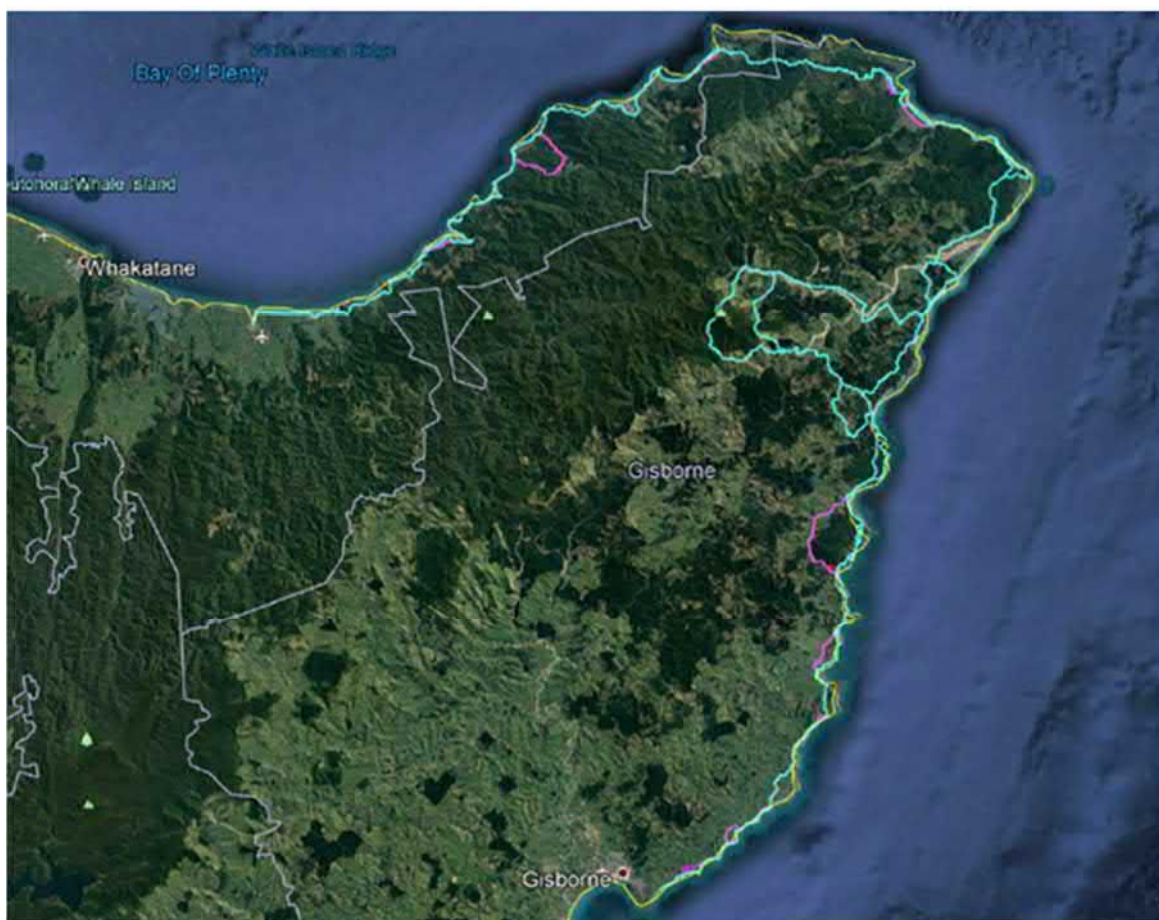
At the early stage of the project Civil Project Solutions (CPS) has developed a high level route for the track, which is shown in the figure below:

Figure 1-1: Provisional route for the Te Ara Tipuna trail.

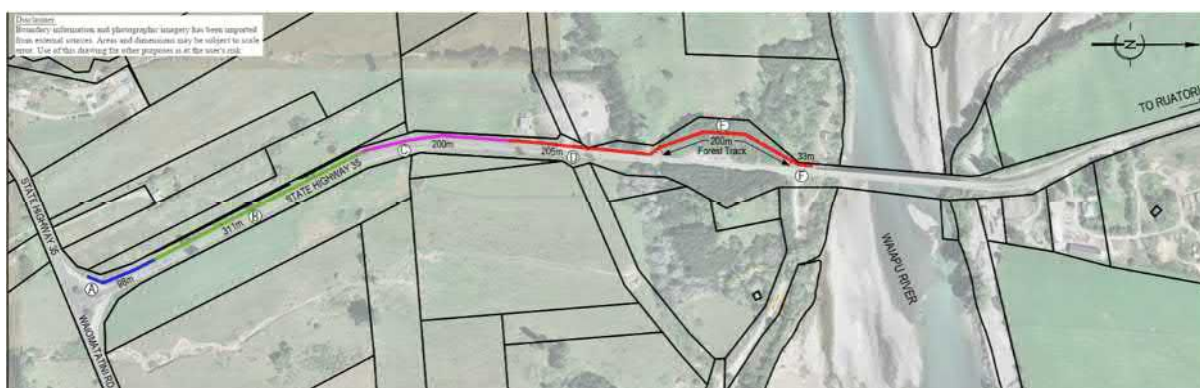
A section of the Te Ara Tipuna Trail in Ruatoria has been chosen to showcase the potential track types of the overall trail. The Ruatoria Route is a 1 km section of four tiers of tracks (raised boardwalks, boardwalks, gravel and standard). The development will include approximately 100 m of raised boardwalks, 300 m of boardwalks, 200 m of gravel track and 440 m of standard track (see below).

Figure 1-2: Ruatoria Route Layout.

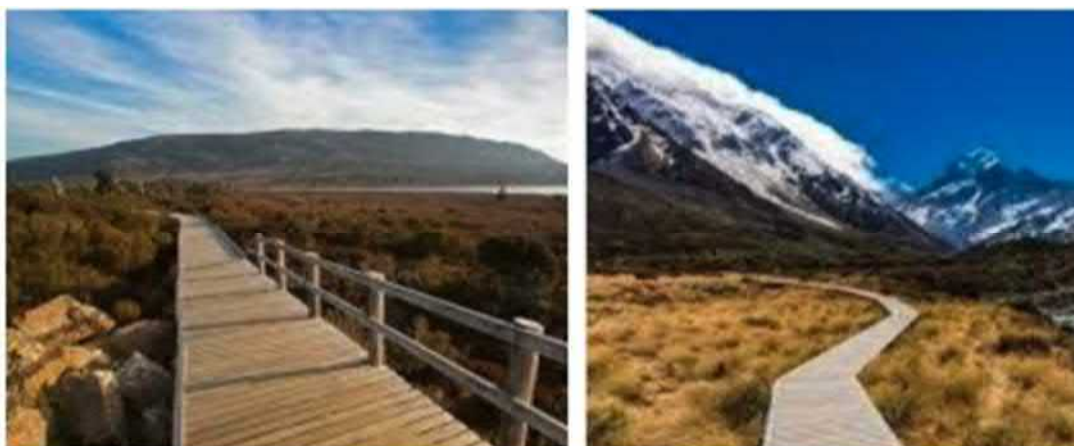
The track is a high quality raised wooden walkway, similar to that constructed between Waikanae and Midway Beach in Gisborne. The wooden walkway is likely to be supported on timber poles embedded approximately 300 – 500 mm below ground level. Figure 1-3 and Figure 1-4 below provides examples and a cross section of the proposed raised boardwalk track.

Figure 1-3: Example image of a proposed raised boardwalk tier track.

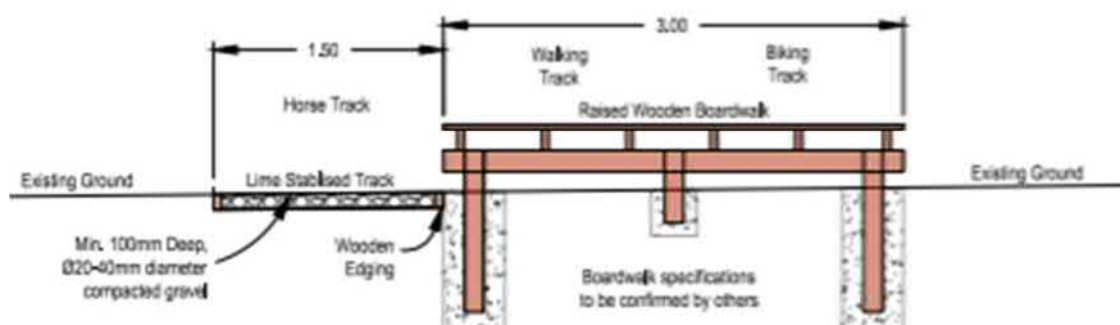
Figure 1-4: Typical cross section of a raised boardwalk.

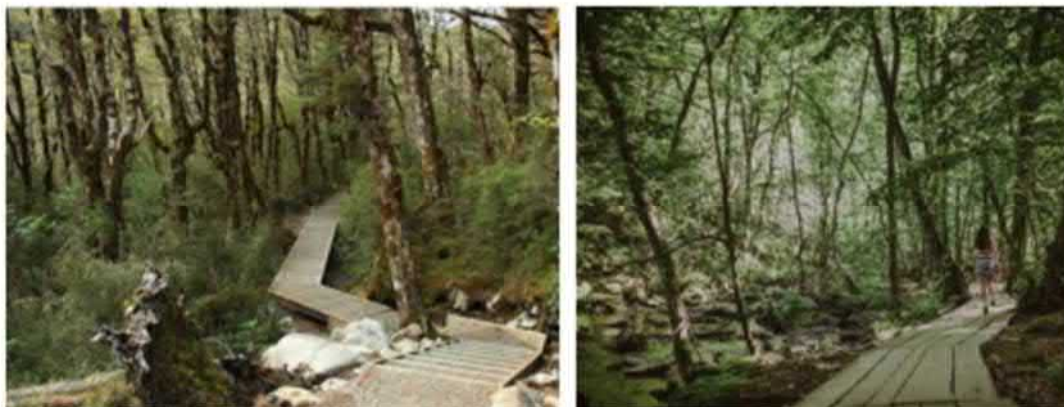
This track is a wooden walkway that bears directly on the ground (i.e. is not raised). This type of track will not be as significant and visually appealing compared to a raised boardwalk track and may have some grassed sections. Figure 1-5 and Figure 1-6 below provide examples and a cross section of a proposed boardwalk tier track.

Figure 1-5: Example image of a proposed boardwalk tier track.

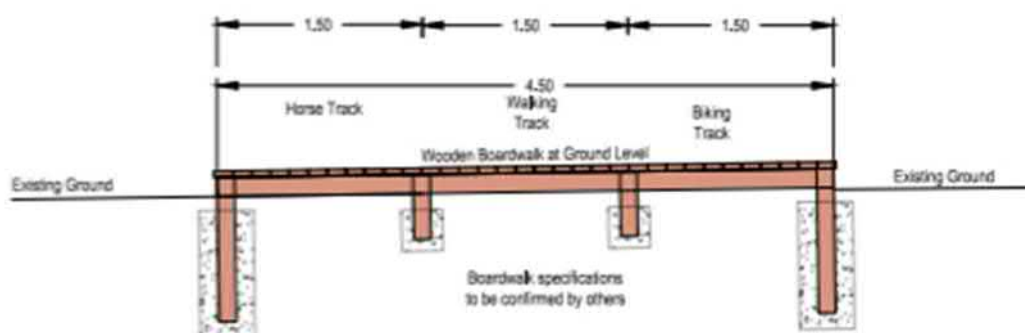
Figure 1-6: Typical cross section of a boardwalk tier track.

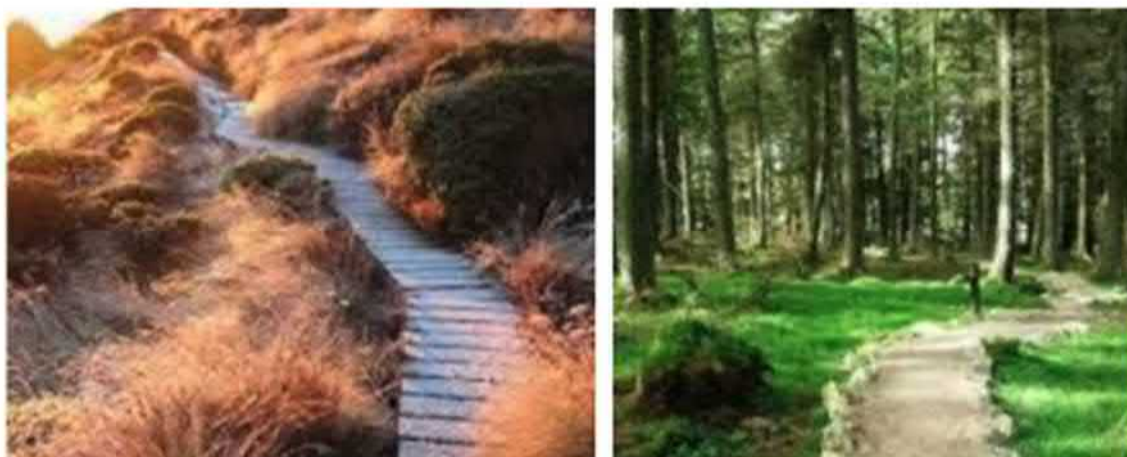
The gravel tier track will have an aggregate surface (100 mm of compacted aggregate) which is crowned in the middle walkway. The gravel track will provide a higher level of service than a farmland or beach track. Figure 1-7 and Figure 1-8 below provides examples and cross section of a proposed gravel tier track.

Figure 1-7: Example image of a proposed gravel tier track.

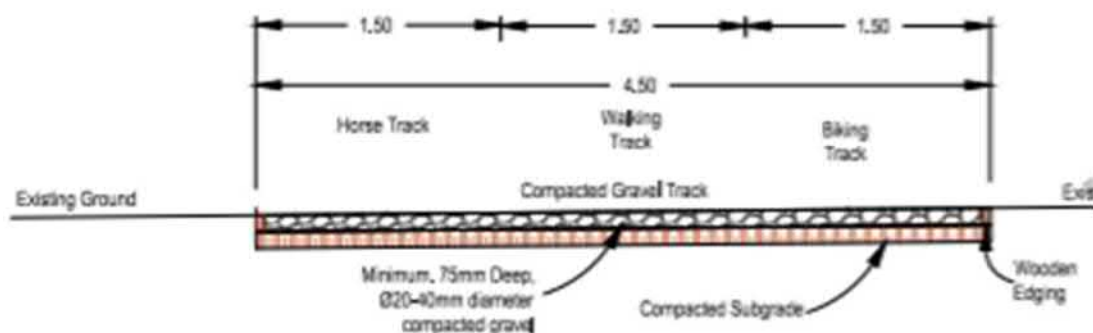
Figure 1-8: Typical cross section of proposed gravel tier track.

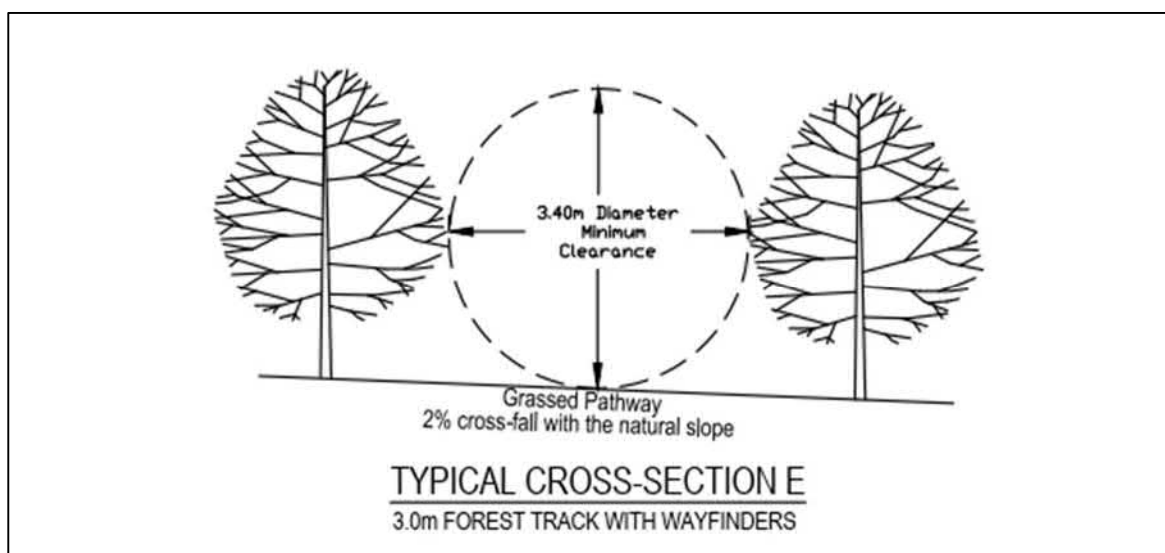
A Standard Tier track is essentially formed within the natural landscape, requiring minimal change to current grades and supported with wayfinder posts. This track will typically be used through bush and farmland and may require the removal of vegetation and limited track sculpting. Figure 1-9 below provides a typical cross section of a Standard Tier track.

Figure 1-9: Typical cross section of a Standard Tier track.

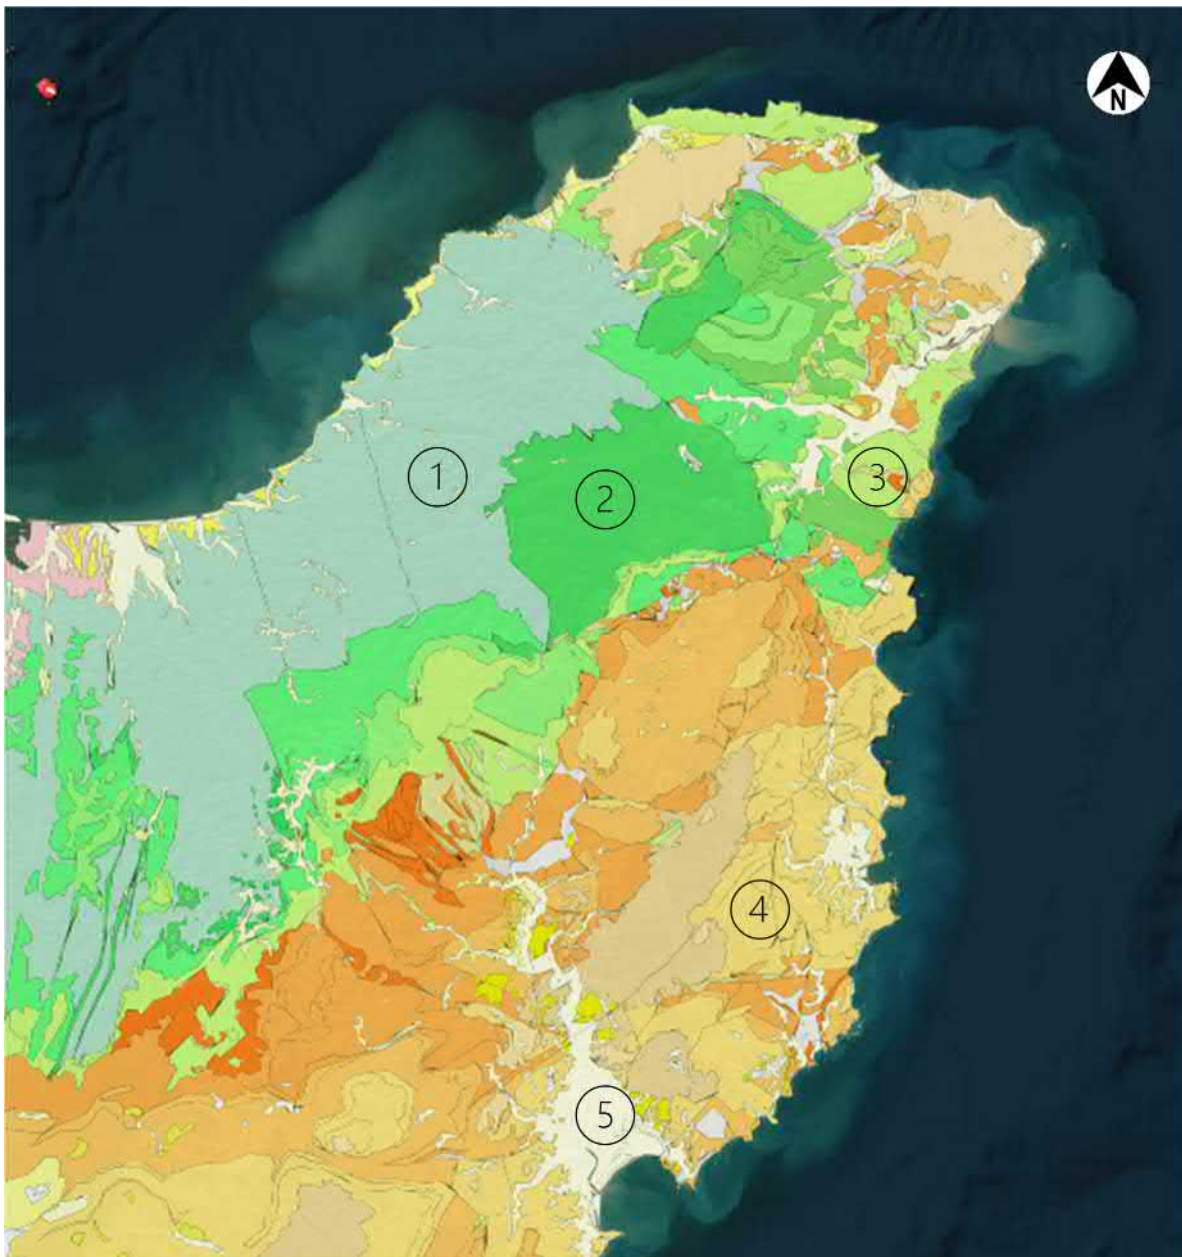
Figure 2-1: Geology map of the East Coast Region. Sourced From GNS Science.
